# Historical Building Report – Part I on **Frith Farm Frith Lane** Wickwar **South Gloucestershire**

August 2011 by Kay Ross

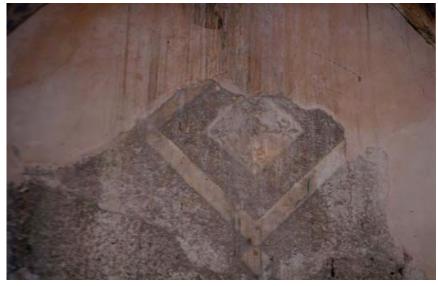
The dating of this phase is informed largely by the raised lozenge discovered by Linda Hall in 1975 on a wall in the attic (2). It is on the east side of the hall stack, which suggests either the eastern end of the house was not in existence or it was only 1 to 1 ½ stories at the time. Now on an internal wall, it was clearly added to the original exterior east wall and retains its render beneath later plasterwork. The raised border encloses a diamond with a raised central rose with a trailing leaf pattern, similar to a Fleur-de-Lys, on all four corners. The lower point has a further diamond below it, which may be repeated on the other 3 points, now covered by plaster. It is possible that further contemporary decoration exists beneath the plasterwork.

## 2 Circa mid 17th century lozenge with former exterior rendering in attic (D & S Duke 1994)

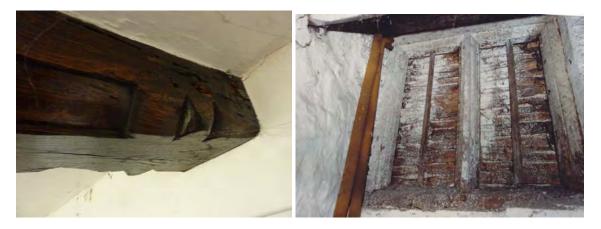
#### 3 Circa early-mid 17th century carved stops and timber mullion window (D & S Duke 1994)

A sole remaining blocked timber ovolo mullioned window [W6] in the north wall of the Parlour Chamber [01-02] can be seen from inside the rear lean-to. Between each of the mullions is a metal security bar set at a 45° angle. Another blocked window of about the same size can be seen in the 1994 plans (20) beside it and a further smaller window lies behind the northern chimney alcove in the same room. Prior to the external rendering of this gable, the blocked window could still be seen (13).

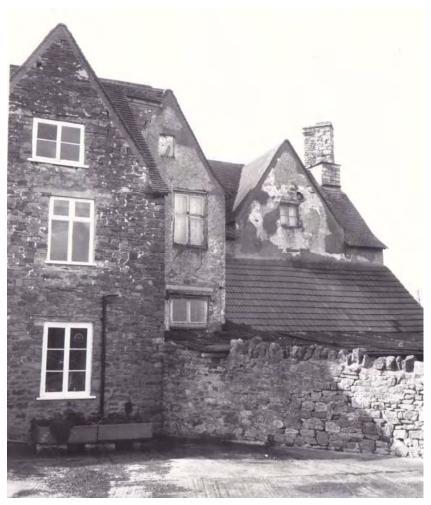
The North Front (11) retained the remains of 2 cross transom windows, the lower one replaced with a c1900 timber mullion with leaded panes, the lower half later blocked by breeze blocks when an additional section of corrugated iron roof was added to the rear catslide roof of the parlour lean-to, running between the stair tower and the west end of the house.

12 Frith Farm North Front 1975 & August 2011

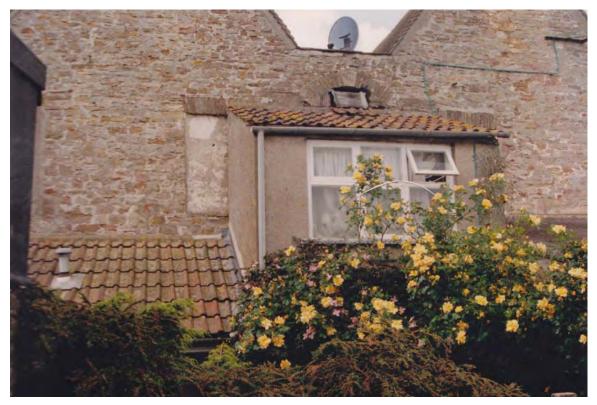
14 1994 Bathroom with larger casement & archway detail with valley gutter above bathroom roof

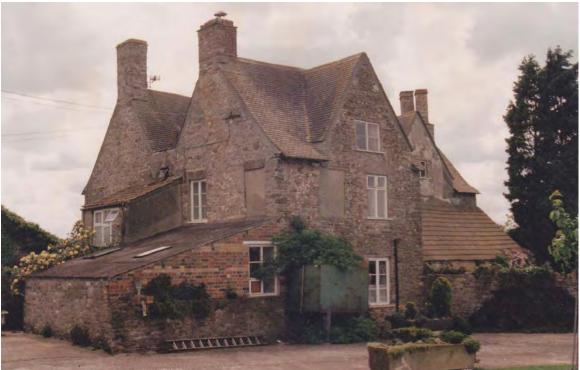
15 1994 north and east fronts with blocked kitchen windows and brick lean-to wall

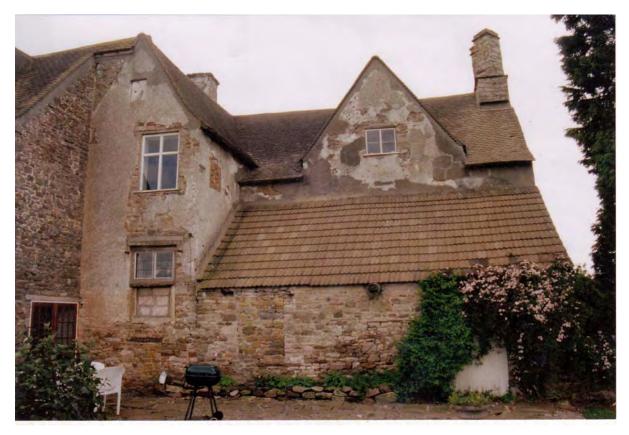
16 The North front showing the partially rendered gables with remains of a stone transom window in the stair tower and various blockages

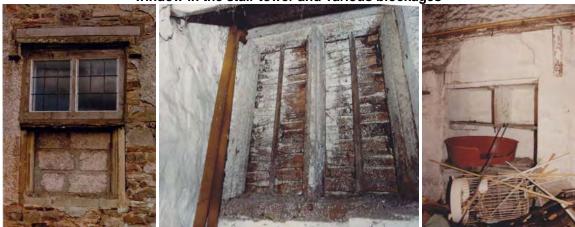
17 Detail of the stair tower with remains of blocked stone transom and c1900 timber leaded mullion; first floor 17th century timber ovolo mullion & blocked doorway in the rear lean-to (north wall)

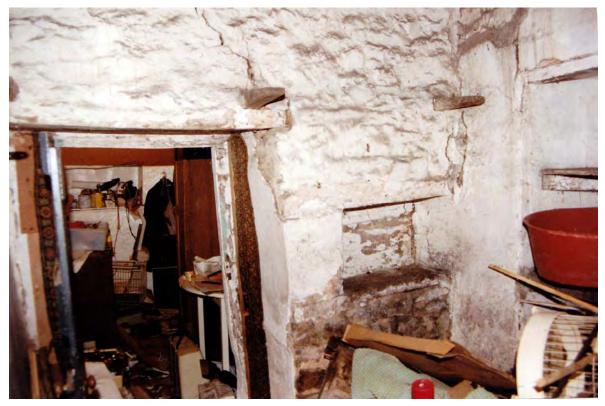
18 1994 Log Store with cheese rack brackets and keeping hole with blocked doorway and arch with further shelving
