McLaughlin Ross llp

**Historical Building Report
on
Frith Farm – The Outbuildings
Frith Lane
Wickwar
South Gloucestershire**

**August 2011
by
Kay Ross**

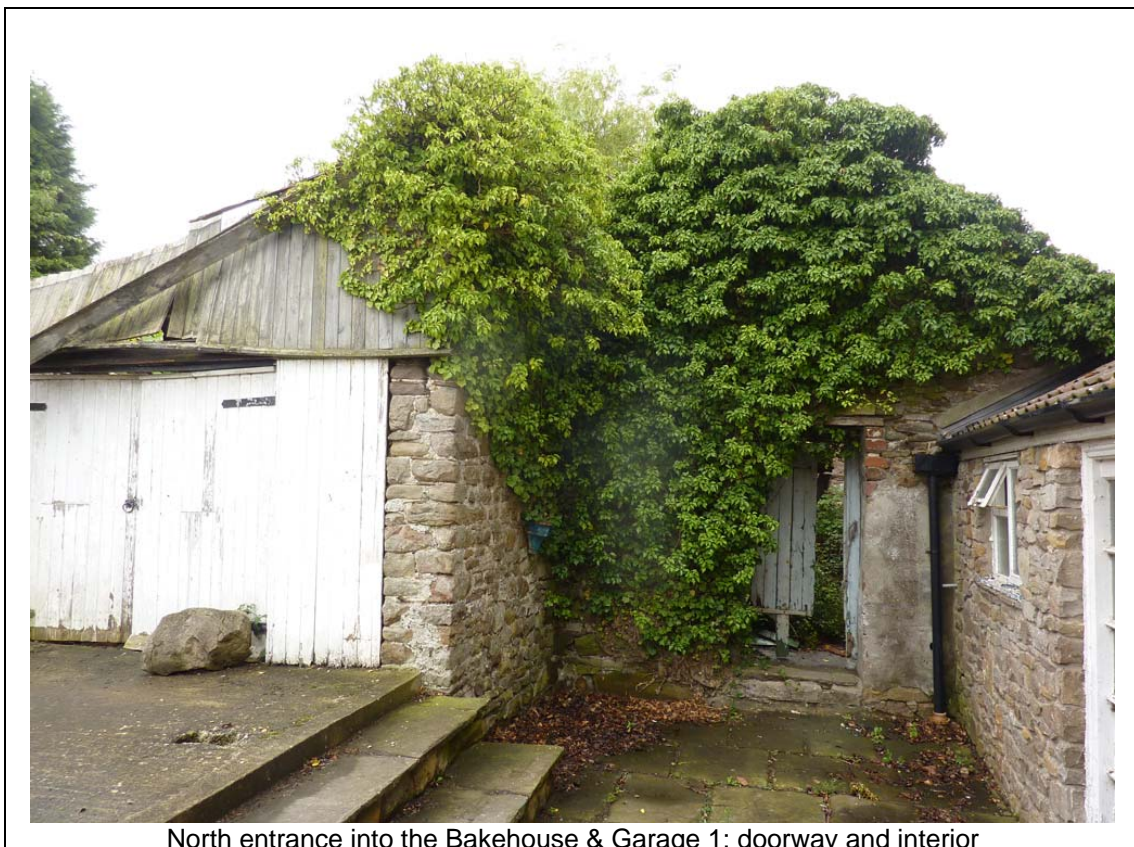
The 1 or possibly 1 ½ storey bakehouse/brewhouse built against the south-east corner of the house has lost its low-pitched double Roman roof (L Hall:1975) in the last 20 years. Built of rubble with a projecting oven, the walls, overgrown with ivy, are structurally unsound. The south wall beside the chimney has collapsed and the west wall is leaning about 18 inches out of true, held in place by the mass of ivy. None of the roof truss and timbers remains, but in 1975 Linda Hall noted

North entrance into the Bakehouse & Garage 1; doorway and interior

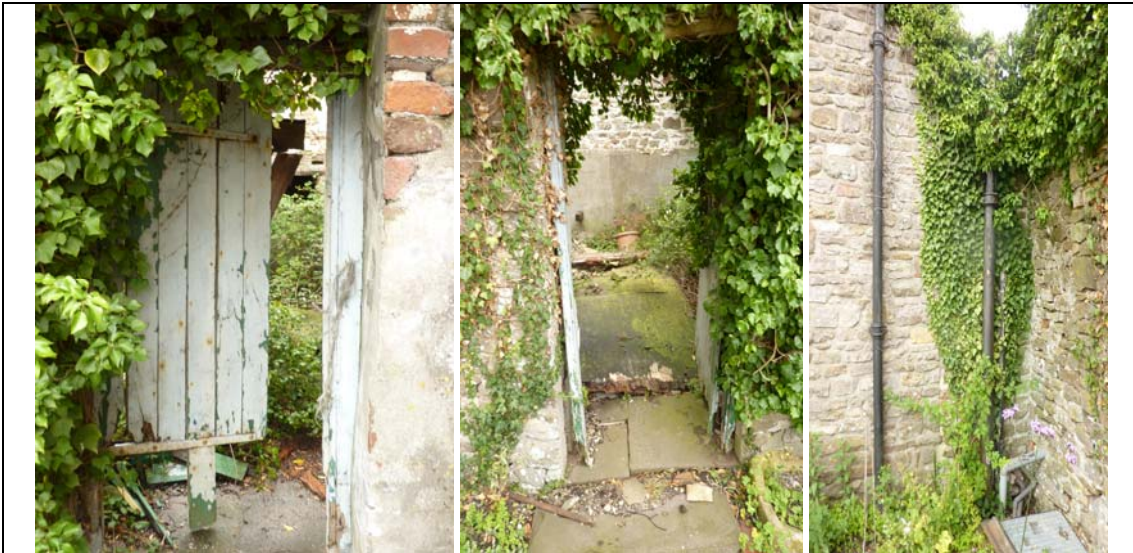
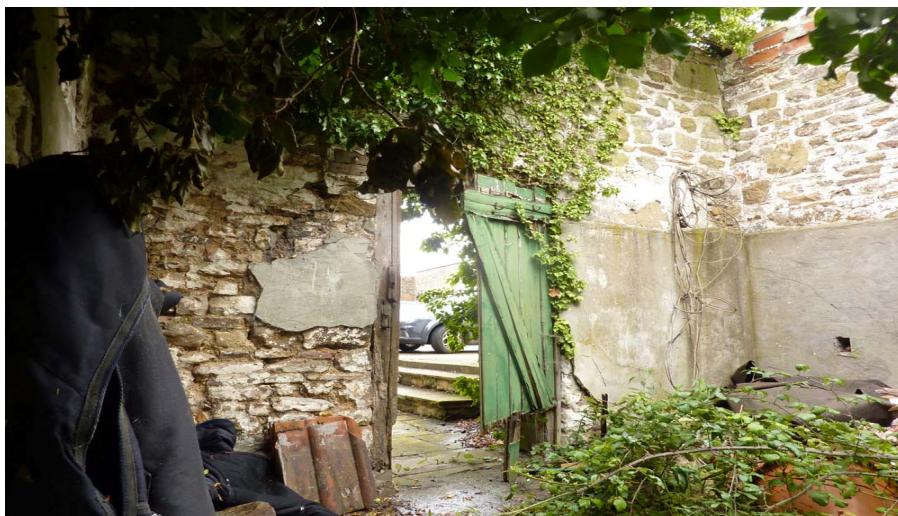
The walls are of rubblestone, rendered up to ceiling level; whilst there are no signs of an upper floor, the walls are just high enough for this to have been a 1 ½ storey building. There are at least 2 courses of later brickwork along the top of parts of the wall. There may well have been a small loft area originally. The remains of the fireplace and chimney stack are extant in the southern wall, the lintel a re-used timber with mortice holes. Both plank doors, in the north and west walls remain, though in poor state. It was not possible to enter the building itself, and much of it is covered with thick ivy. Along the exterior south wall is the remains of a square stone structure and a raised stone trough.

Interior rendered up to door level level; remains of fireplace with re-used timber lintel

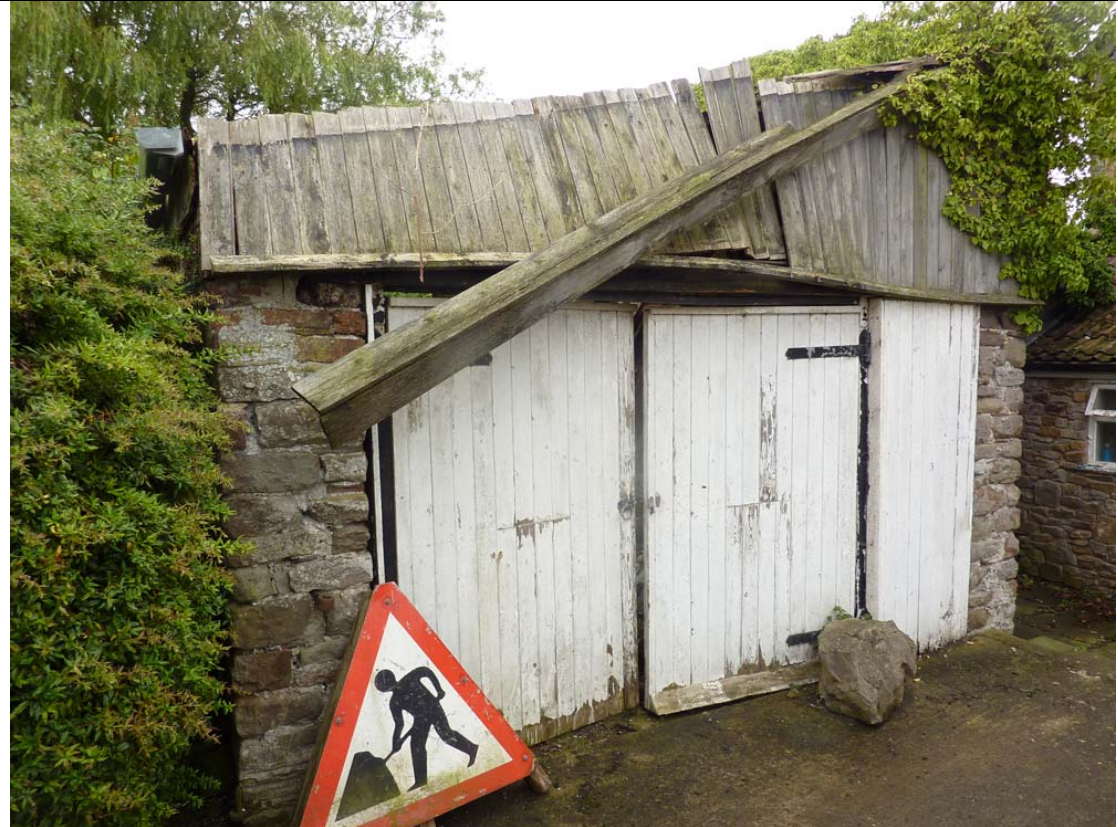
The garage, for which there is little indication of the original purpose, was built alongside the bakehouse, sharing the party wall. The timber garage doors and cladding over are in poor state and it was not possible to either open the doors or enter the building. What was visible within the weed and ivy grown interior were stone walls and the remains of timber trusses. The depth of the ivy made it difficult to ascertain how much of the stone walls remain, although that along the west perimeter is intact.

Garage north front; interior with collapsed roof truss & stone trough and former structure to south of the 2 buildings

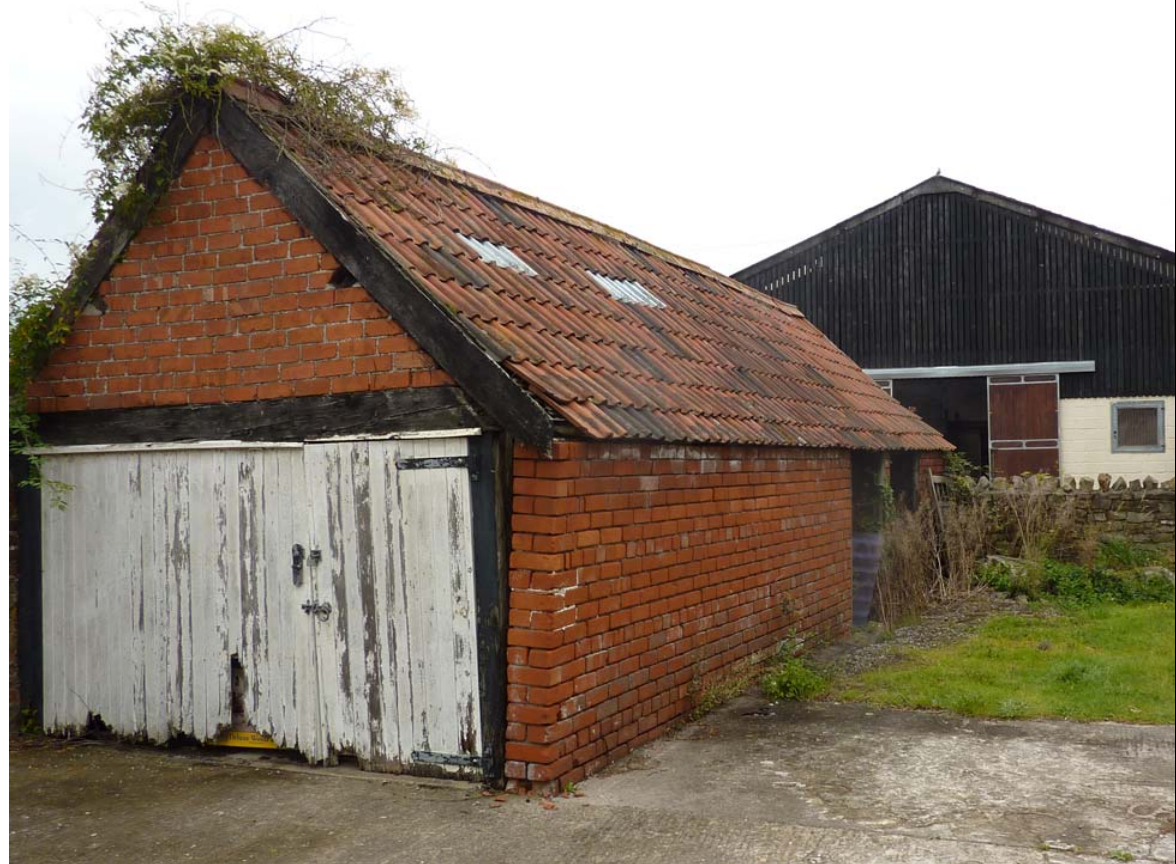
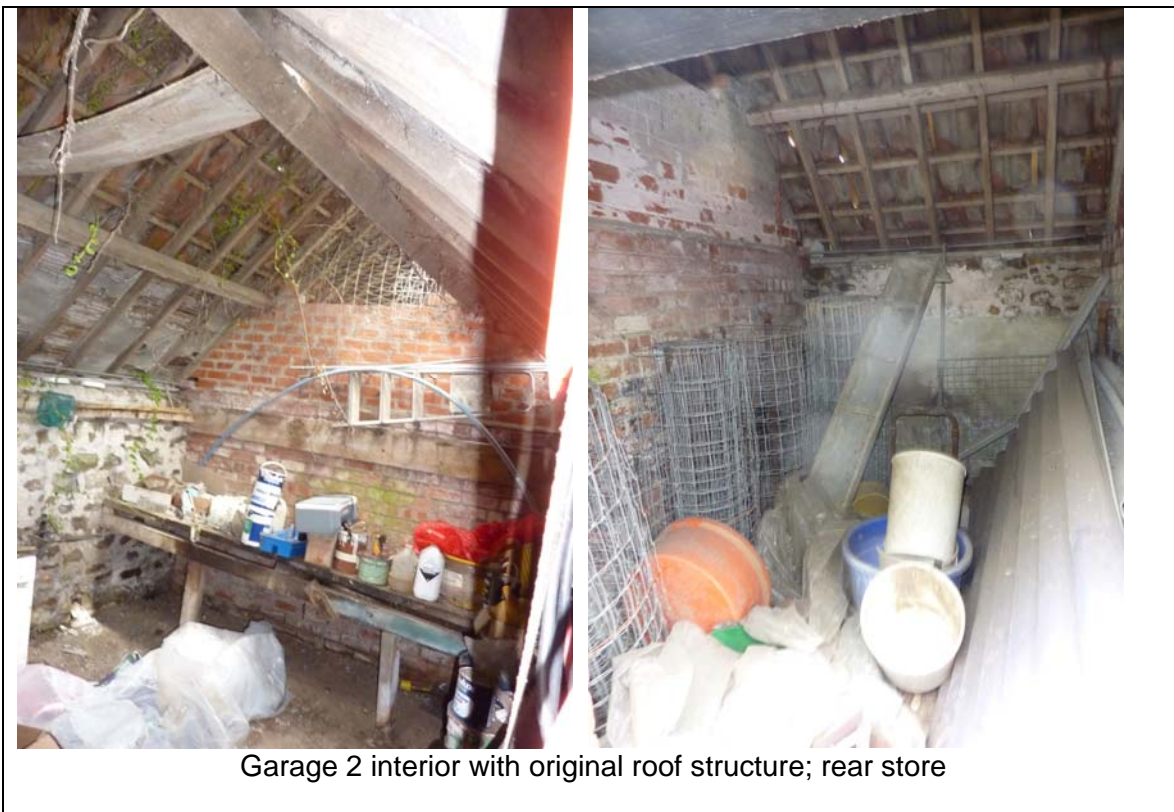
The largely brick built garage on the north-east side was built between 1903 and 1921, incorporating an existing stone boundary wall on the north and east side. It was built below the southern end of the 'L' shaped complex. The roof is clay tiles and the pair of garage doors are similar to those of Garage 1. Probably built as a garage, it may have housed tractors or other farm machinery. The brick south wall is coming away from the rest of the structure and it was not possible to enter or to open the doors. The rear has a narrow separate store with a high window in the east gable.

Garage 2 interior with original roof structure; rear store

The brick garage [2], built c1920, incorporates two earlier stone boundary walls forming the north and east walls. There is a further storage room across the east wall. The building is in a hazardous state, the brick wall coming away, but appears to have been purpose built as a garage. The double Roman tile roof and trusses are intact. The barn to the north of the house [3] is probably one of the earliest buildings, extant in the 1840s. The roof gables have clearly been rebuilt, the rear wall, with a vertical straight join between, continuing westwards to incorporate a further ruined building. The barn has been re-roofed and timber clad internally with a new stable door and partially blocked opening in the rear wall.

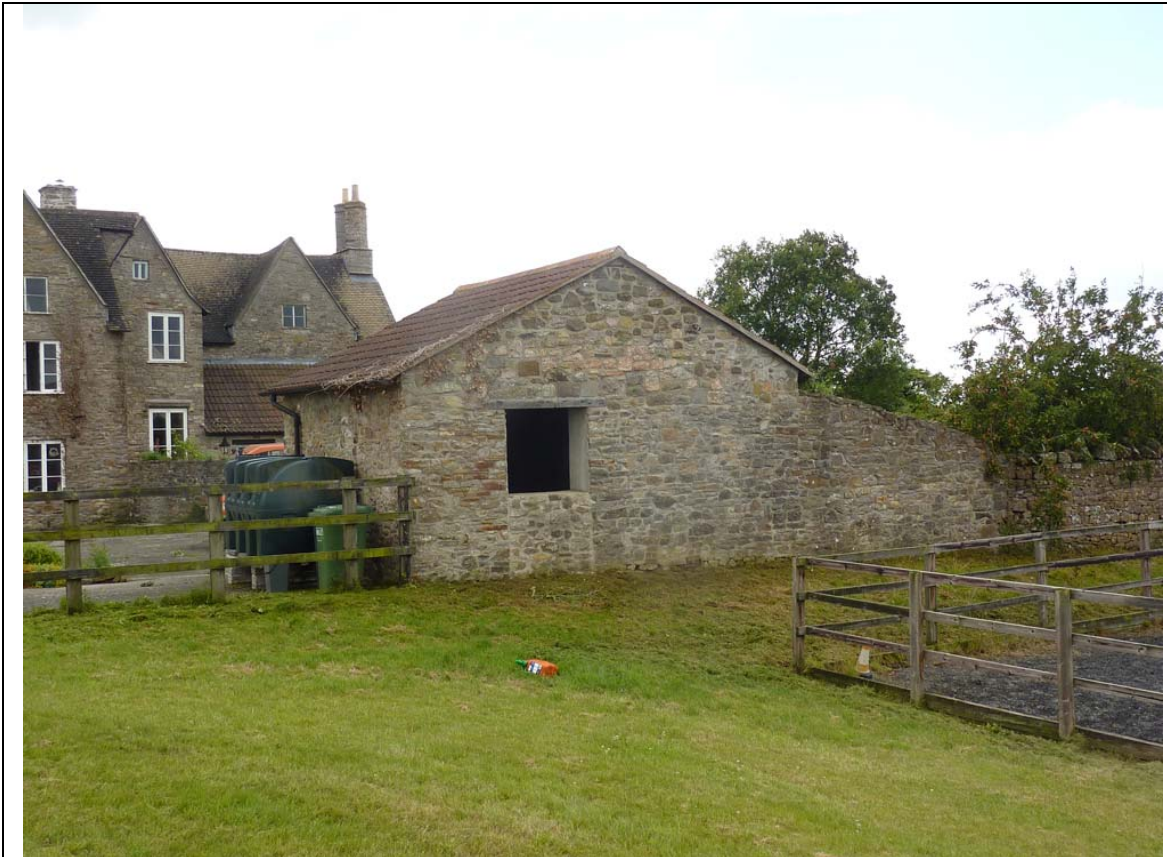
The roof has clearly been rebuilt above eaves level at the rear, and the line of a lower roof exists on the south front. This front has new timber and metal stable doors with a modern timber lintel. Two pintles for a gate remain embedded towards the front of the east wall. The rear doorway has been blocked up to form an unglazed opening. The roof is tiled with new clay tiles. The interior has been rendered more recently, with a ventilation panel above the southern doors. The roof is clad in timber boarding, making it dry and serviceable, although there is a damp patch above the doorway. It is currently in use as a storage facility.

Barn looking south towards Farmhouse; south and east fronts

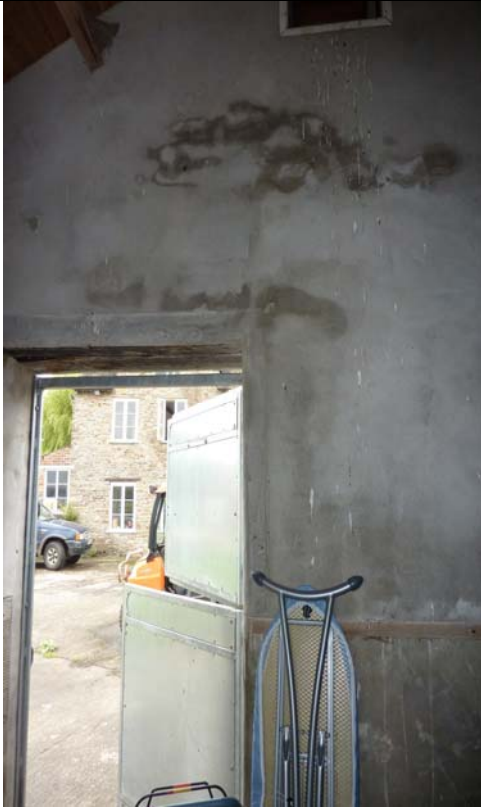
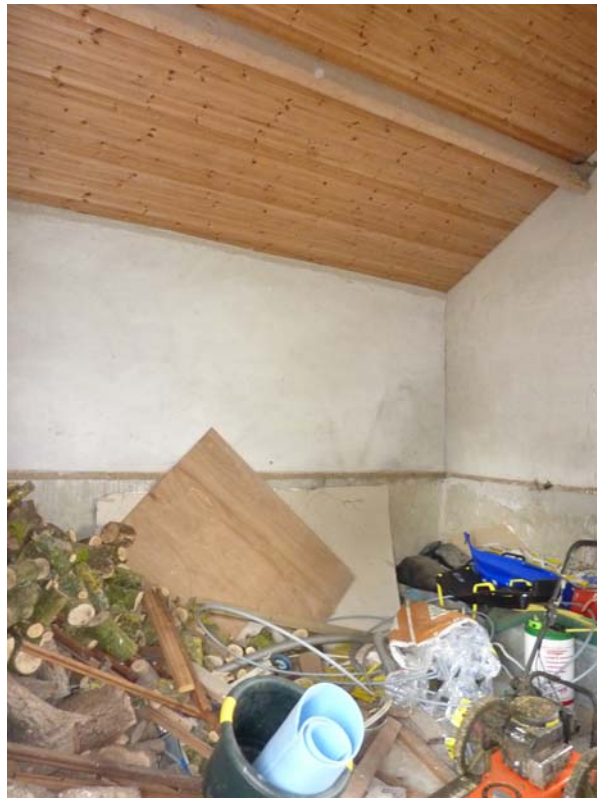
Interior looking south towards Farmhouse; looking north-west; timber clad roof

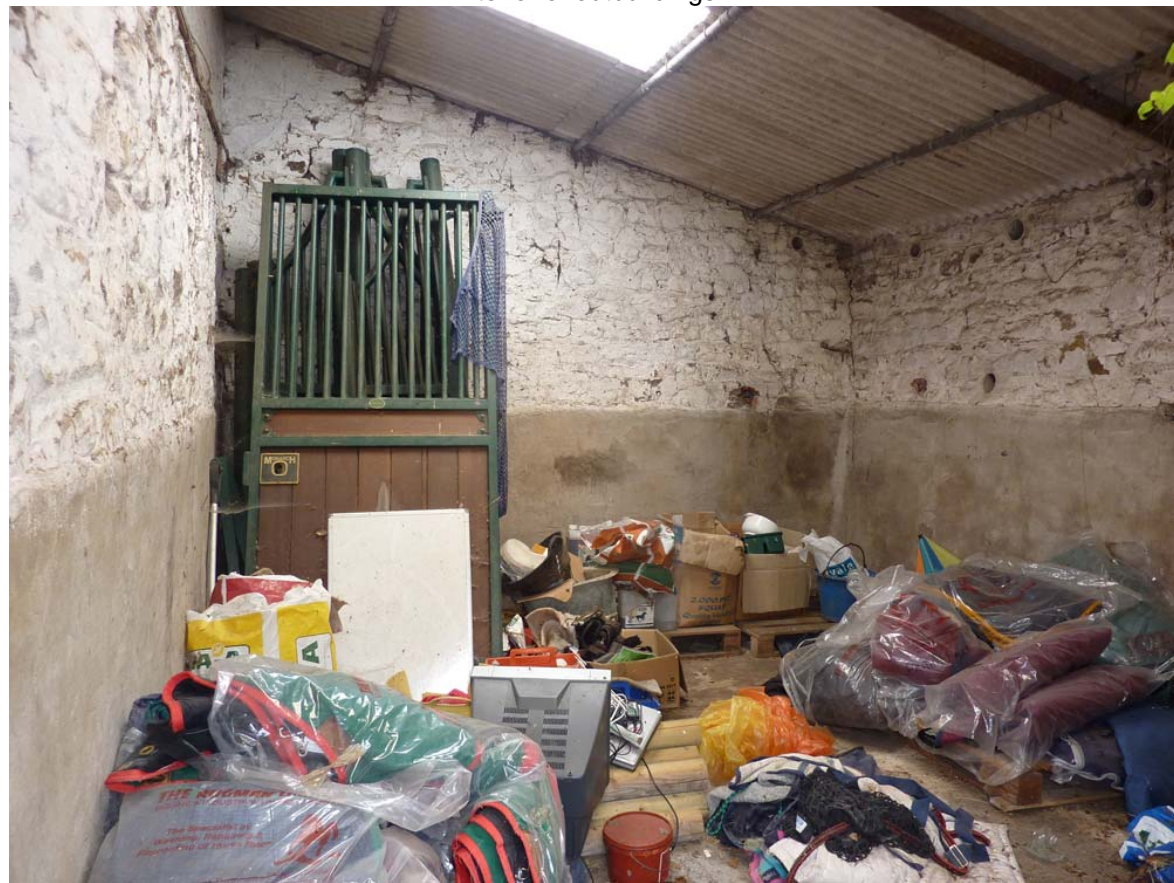
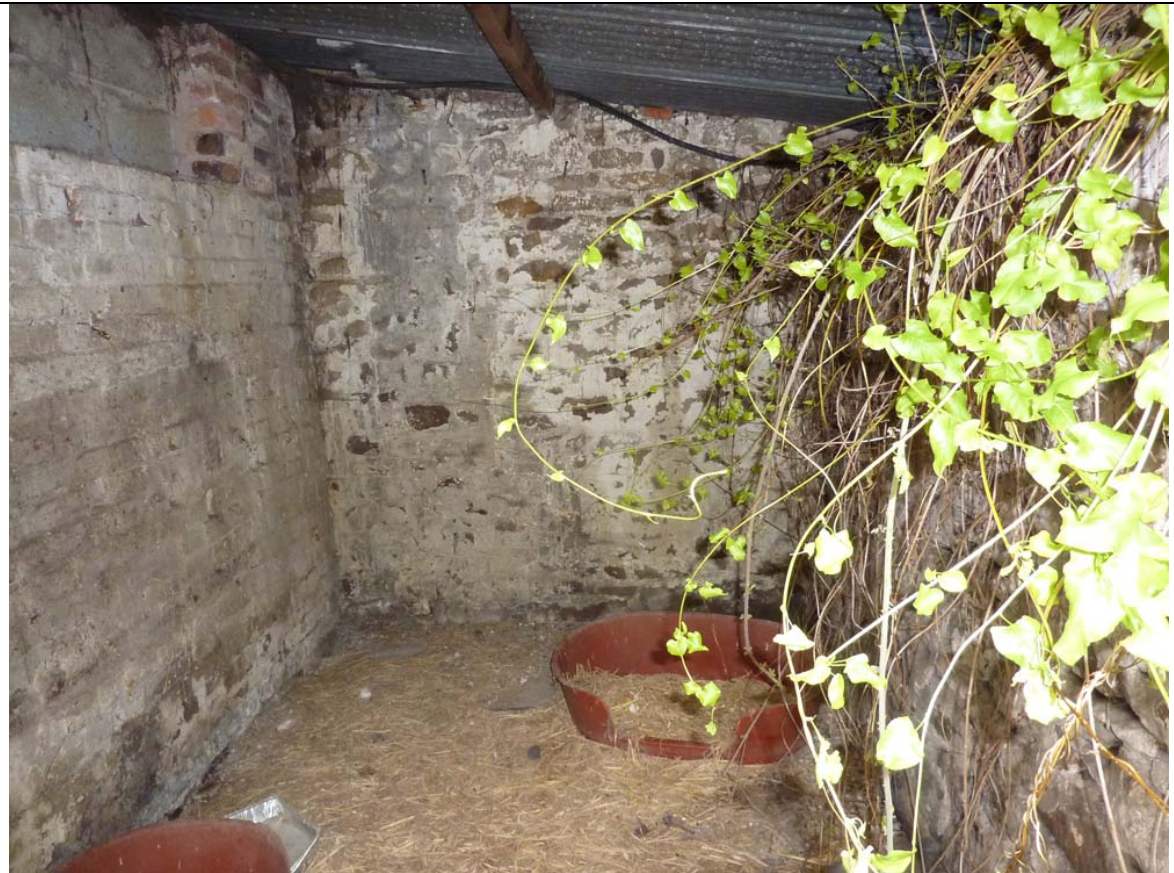
The jumble of stone structures that remain around the north-eastern corner of the yard have been substantially rebuilt over the years, patched up with whatever practical materials were to hand, as with many farm buildings. Since it ceased to be a working farm, the buildings have been used for storage and have fallen into disrepair. Roofing has been replaced with corrugated iron, concrete blocks, re-used bricks and cement render used to repair walls. Some of the buildings' walls have been reduced in height to low stone walls with soldier stone cappings. Internally, one or two have been rendered to a height of about 3 feet. None of the roofs appear to have retained original timber trusses or floor coverings. The concrete yard floor shows signs of a variety of uses and temporary structures.

Interior of outbuildings; detail of patched up external walls

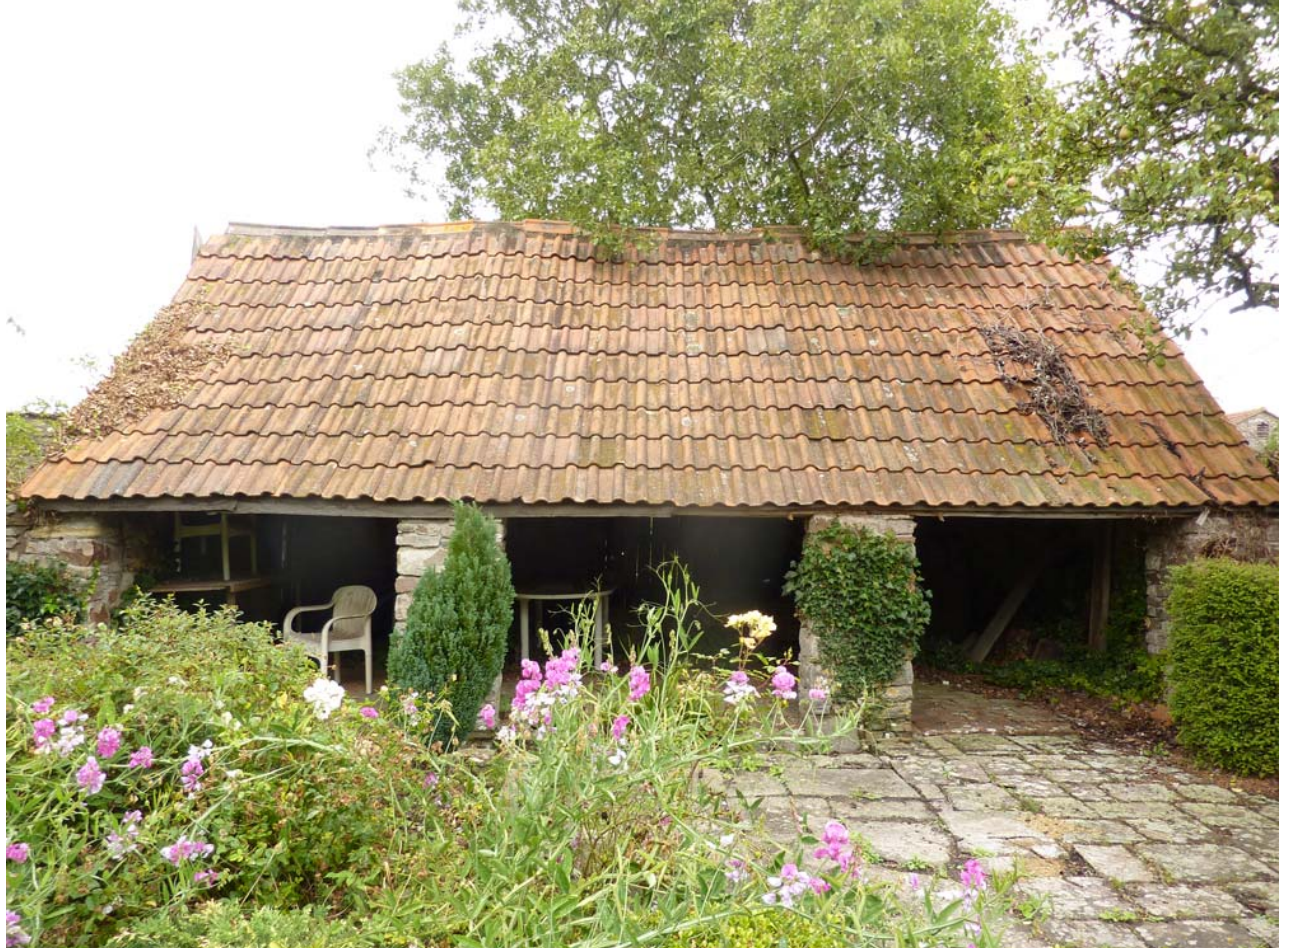
The cattle shed is the only outbuilding, other than Garage 2, to retain its original roof trusses and its roof intact. Located to the west of the house, this long stone building has a partially timber clad west gable. Open along the south front with stone pillars supporting the tile roof, there is a board door in the north wall onto the former yard. This long open-sided building dates from the second half of the 19th century (2), replacing an earlier small square structure on the site. The marks on the underside of the trusses and rafters indicate there was a lath ceiling at one time.

South open front of cattle shed
