Arboricultural Assessment

**Land at
Badminton Road
Old Sodbury**

Tim Pursey

Arboricultural Consultant

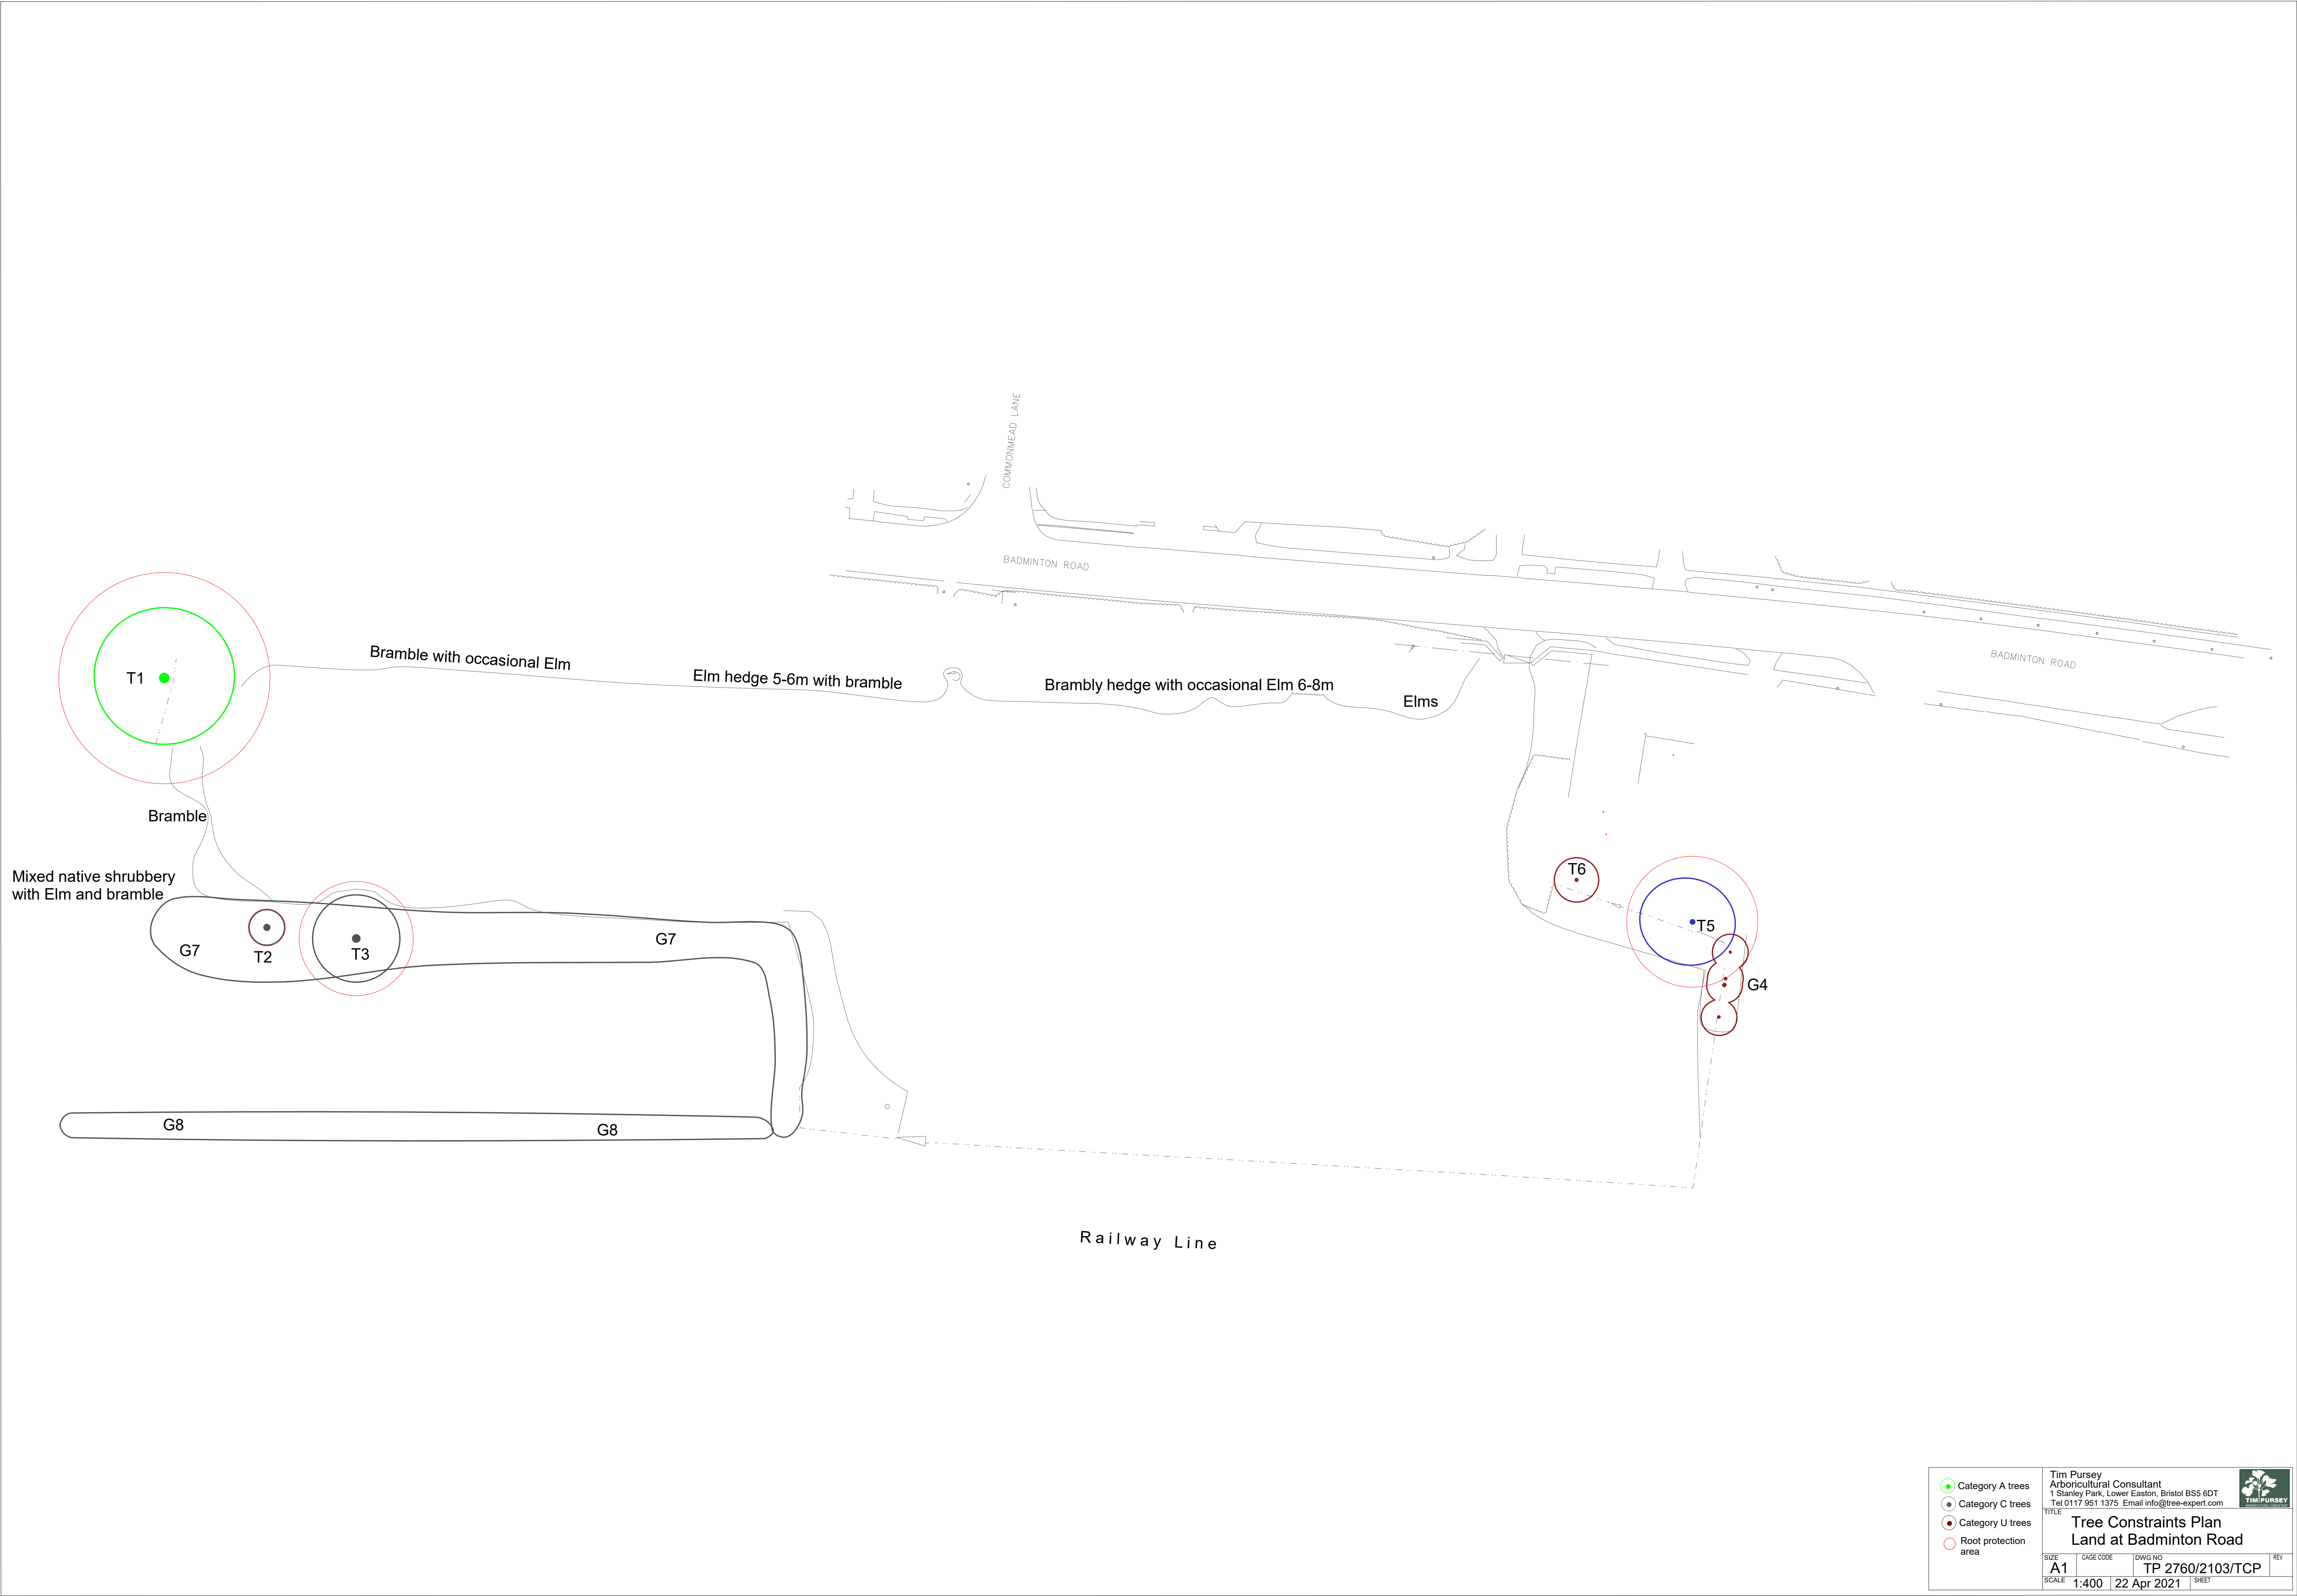
All tree protection measures will be inspected prior to commencement of ANY works on site. There will be no works whatsoever until protective measures have been inspected and approved by the project arboriculturist/
