# Historical Building Report – Part I on **Frith Farm Frith Lane** Wickwar **South Gloucestershire**

August 2011 by Kay Ross

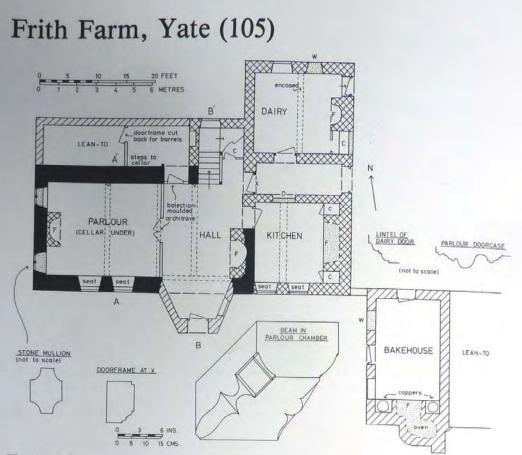
Figure 142.

FEATURES: GROUND FLOOR. Hall, parlour, dairy fireplaces have curved openings. In parlour, deeply-chamfered beam with step stops at N. end. Chamfered beam in hall, with flat stops, supported at S. end by cross-beam. Doors to parlour, lean-to, and cupboard under stairs have bolection-moulded architraves (figure 142). Fireplace had similarly moulded surround, unfortunately destroyed by fire (i.f.o.). W. doorframe in passage has double-ovolo moulding on E. side (figure 142). At E. end, very weathered doorframe. Dairy doorframe has scroll- and ovolo-moulded lintel (figure 142); jambs have been partly roughed out for moulding, never completed. Very fine dog-leg stair has twisted balusters, moulded hand-rail, carved pendants and finials (figure 144).

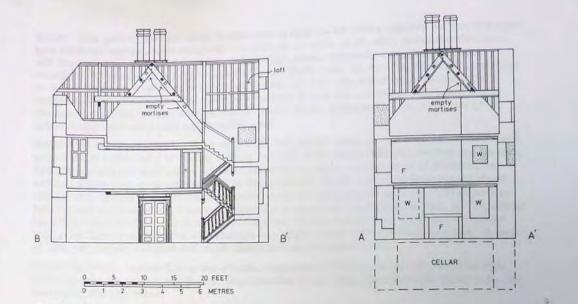
Figure 143.

EXTERNAL FEATURES. Symmetrical elevation, two and a half storeys, diagonal chimneys on parlour stack. Two gables and central projecting bay (which has half-hipped roof) had ball finials (i.f.o.). House L shaped, with stair turret in angle. Rear wing, unusually, roofed parallel to main roof. Windows have angled hood-moulds above modern sashes. Two hollow-chamfered stone cross-windows survive, blocked, in W. wall (figure 143); wooden cross-windows in stair turret.
