McLaughlin Ross llp

**Historical Building Report
on
Frith Farm – The Outbuildings
Frith Lane
Wickwar
South Gloucestershire**

**August 2011
by
Kay Ross**

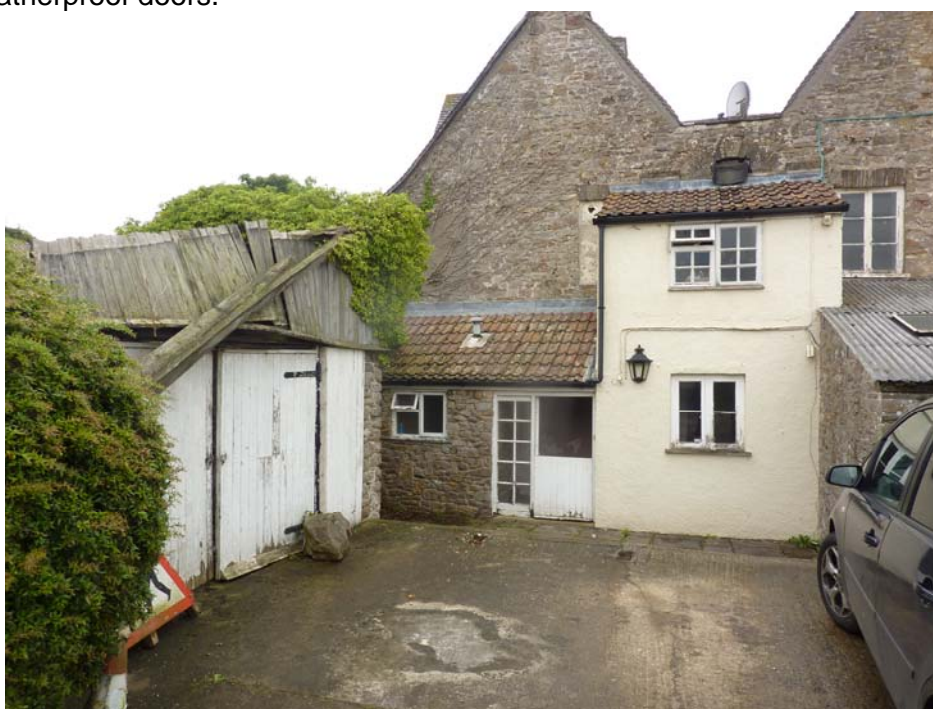
Garage 1 with bakehouse [1] behind to south-east of the farmhouse

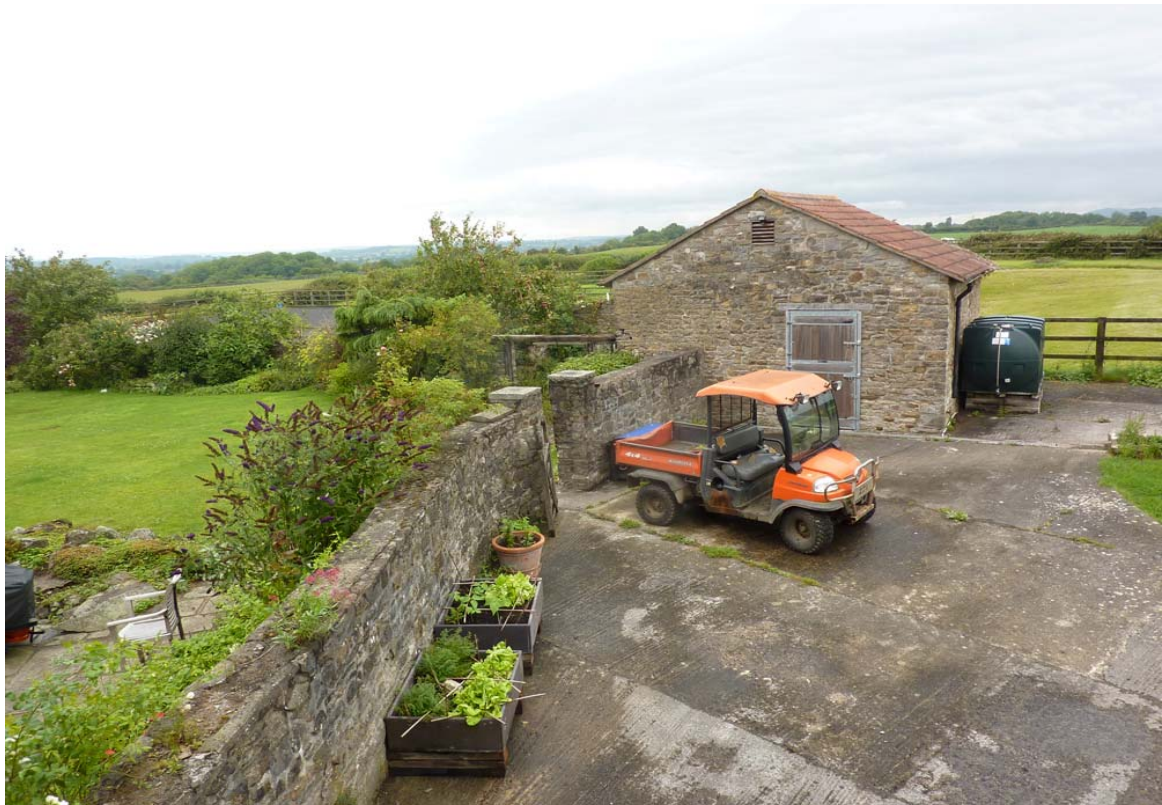
Barn [3] with boundary wall running north from the farmhouse; Barn to left with gap along original north wing of 'L' shaped complex;

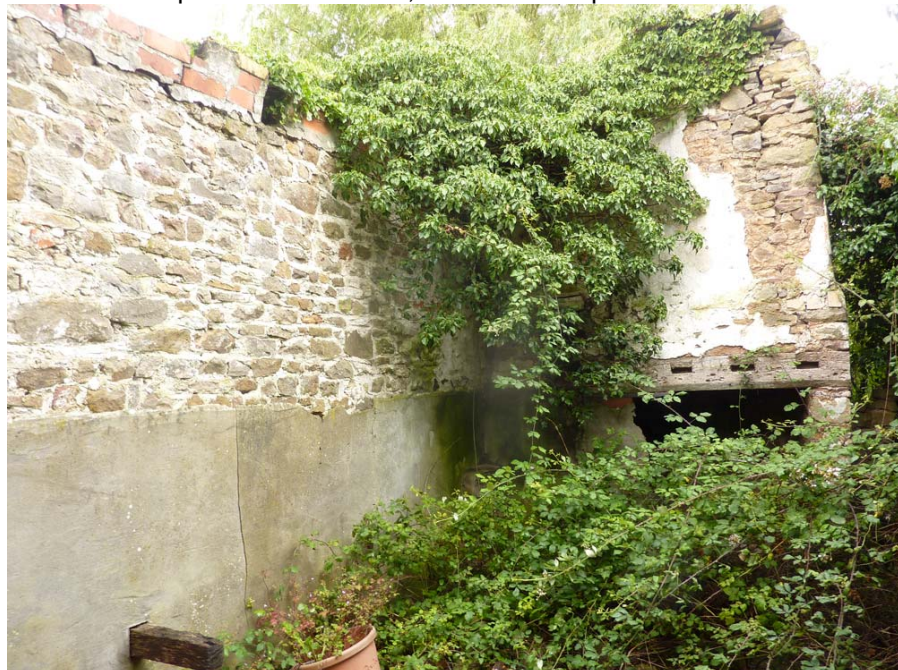
Garage 1 [1]

The garage, for which there is little indication of the original purpose, was built alongside the bakehouse, sharing the party wall. The timber garage doors and cladding over are in poor state and it was not possible to either open the doors or enter the building. What was visible within the weed and ivy grown interior were stone walls and the remains of timber trusses. The depth of the ivy made it difficult to ascertain how much of the stone walls remain, although that along the west perimeter is intact.

Garage north front; interior with collapsed roof truss & stone trough and former structure to south of the 2 buildings

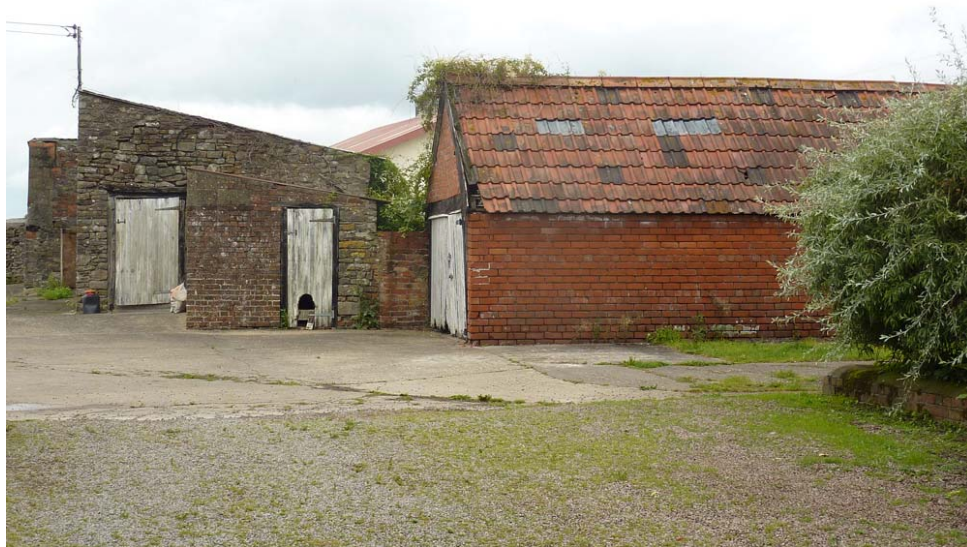
Garage 1 looking north and west

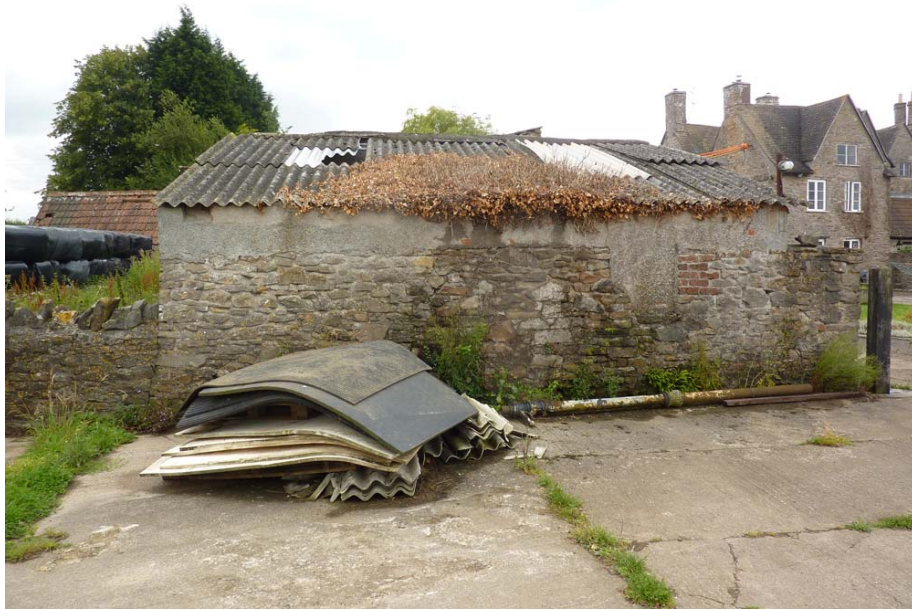
The jumble of stone structures that remain around the north-eastern corner of the yard have been substantially rebuilt over the years, patched up with whatever practical materials were to hand, as with many farm buildings. Since it ceased to be a working farm, the buildings have been used for storage and have fallen into disrepair. Roofing has been replaced with corrugated iron, concrete blocks, re-used bricks and cement render used to repair walls. Some of the buildings' walls have been reduced in height to low stone walls with soldier stone cappings. Internally, one or two have been rendered to a height of about 3 feet. None of the roofs appear to have retained original timber trusses or floor coverings. The concrete yard floor shows signs of a variety of uses and temporary structures.

Outbuildings and yard looking south and south-west

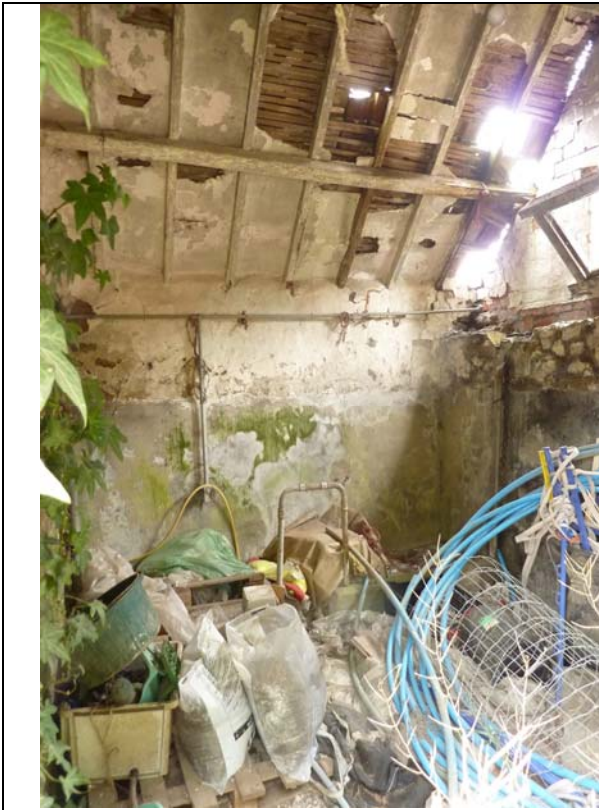
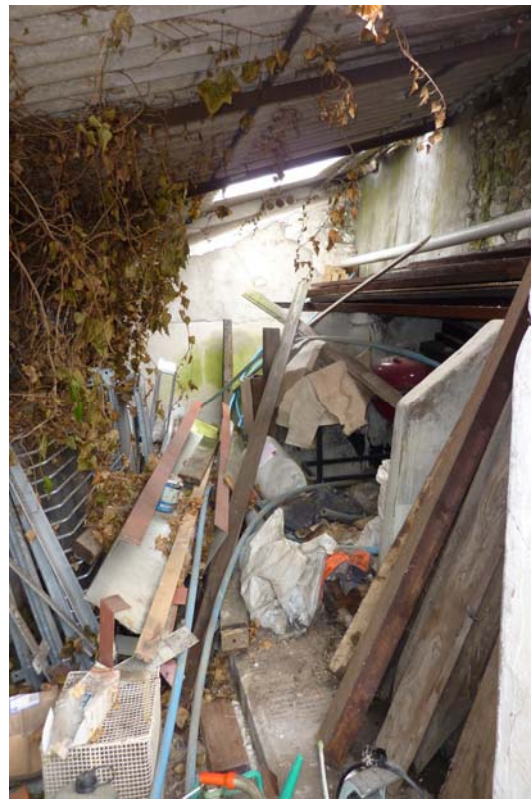
Interior of outbuildings

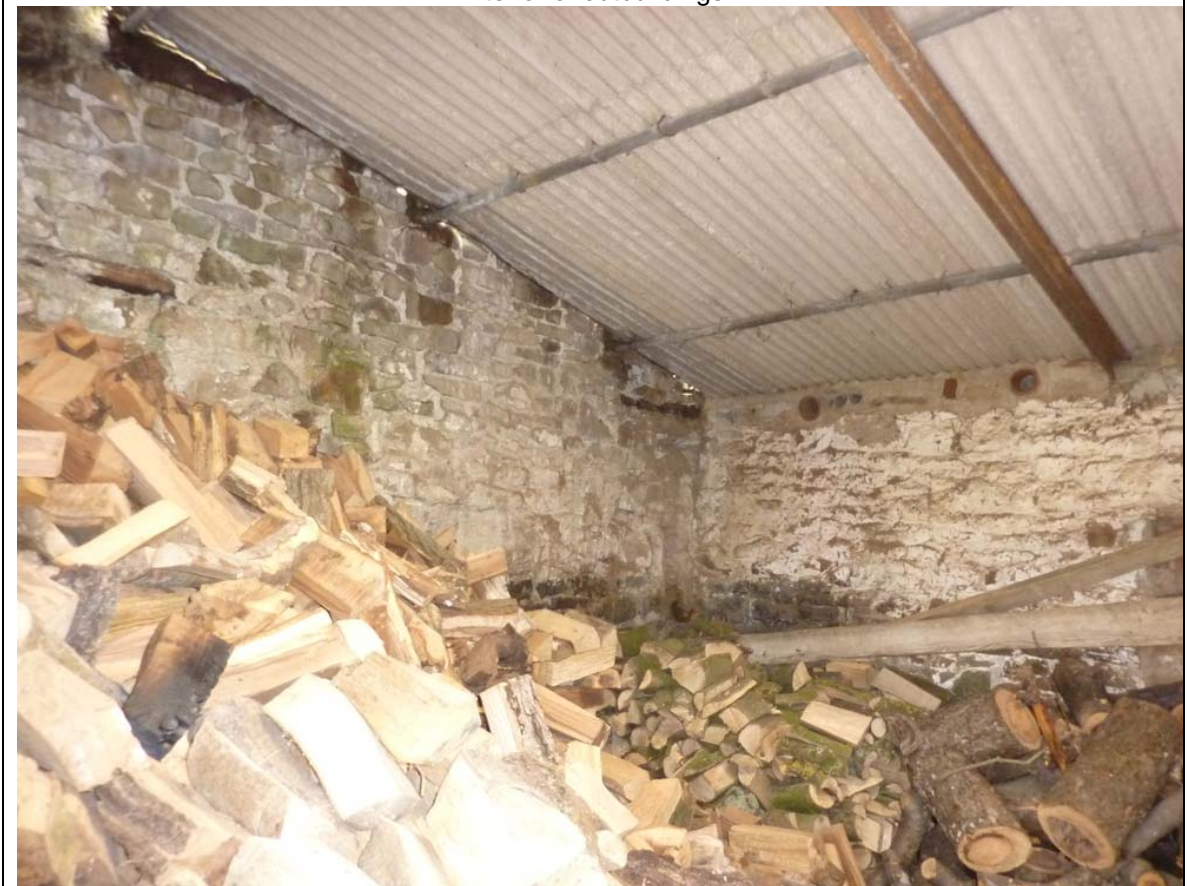
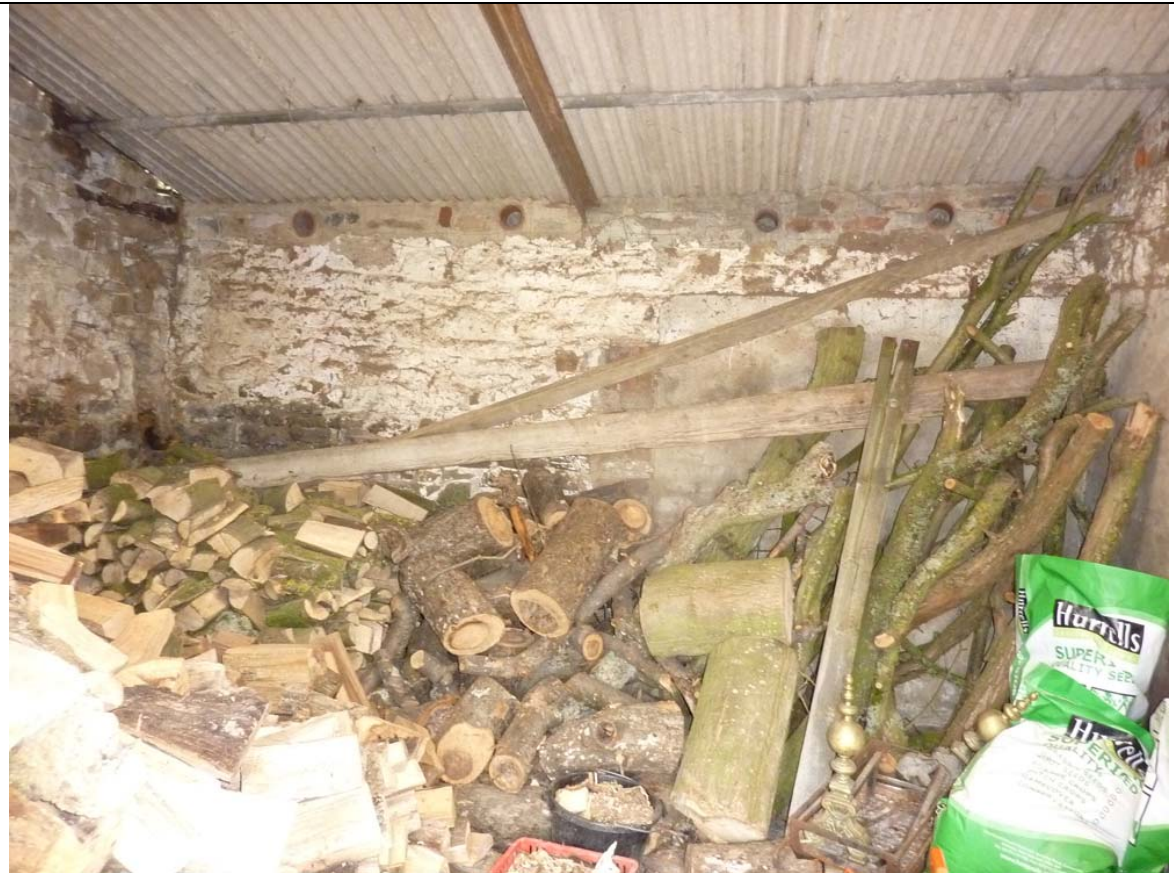
Interior of outbuildings

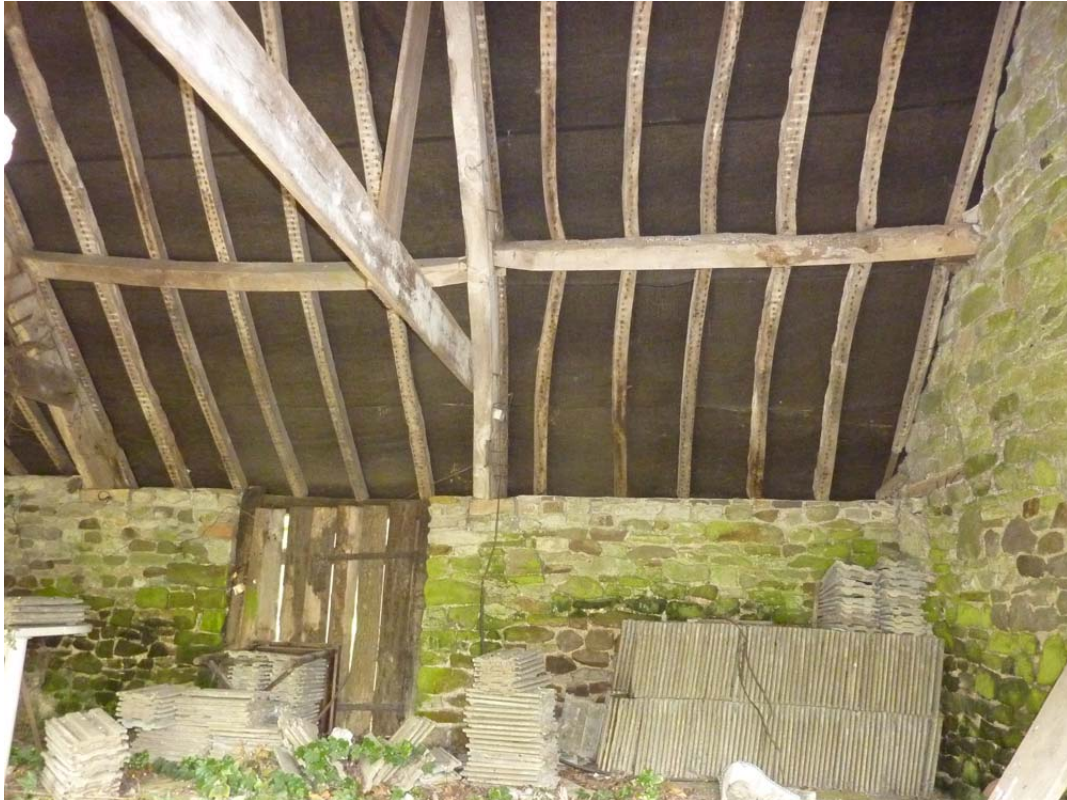
The cattle shed is the only outbuilding, other than Garage 2, to retain its original roof trusses and its roof intact. Located to the west of the house, this long stone building has a partially timber clad west gable. Open along the south front with stone pillars supporting the tile roof, there is a board door in the north wall onto the former yard. This long open-sided building dates from the second half of the 19th century (2), replacing an earlier small square structure on the site. The marks on the underside of the trusses and rafters indicate there was a lath ceiling at one time.

Cattle shed looking north and north-west
