**McLaughlin Ross llp**

# **Historical Building Report – Part II** **on** **Frith Farm** **Frith Lane** **Wickwar** **South Gloucestershire**

**August 2011**  
**by**  
**Kay Ross**

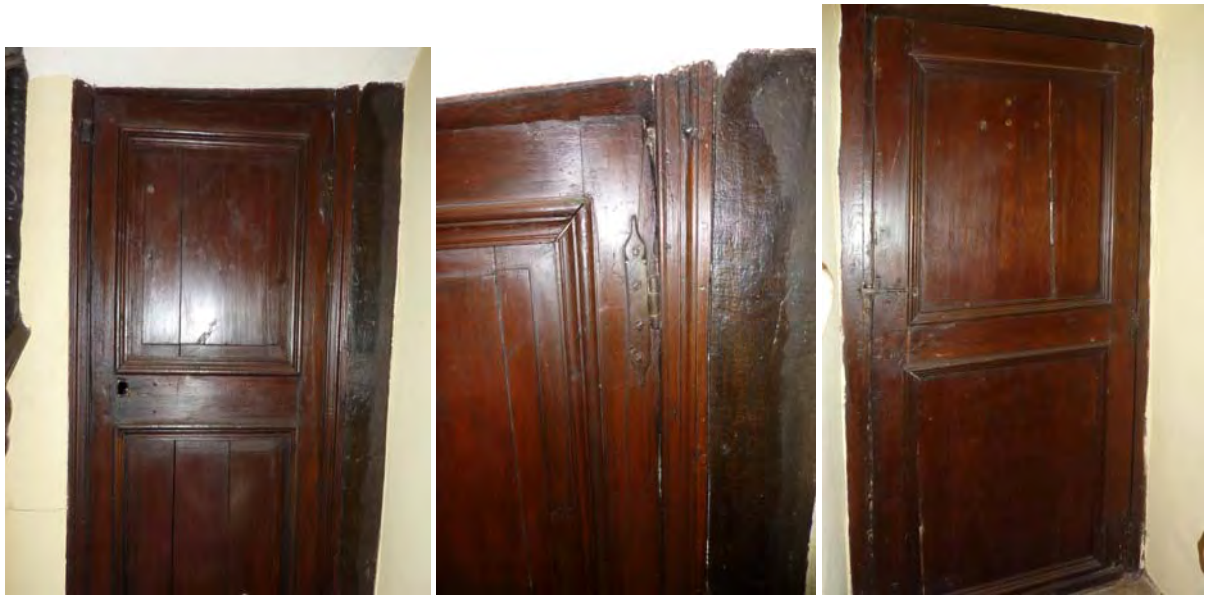
Cupboard under staircase & hinge; Sitting Room door and hinges

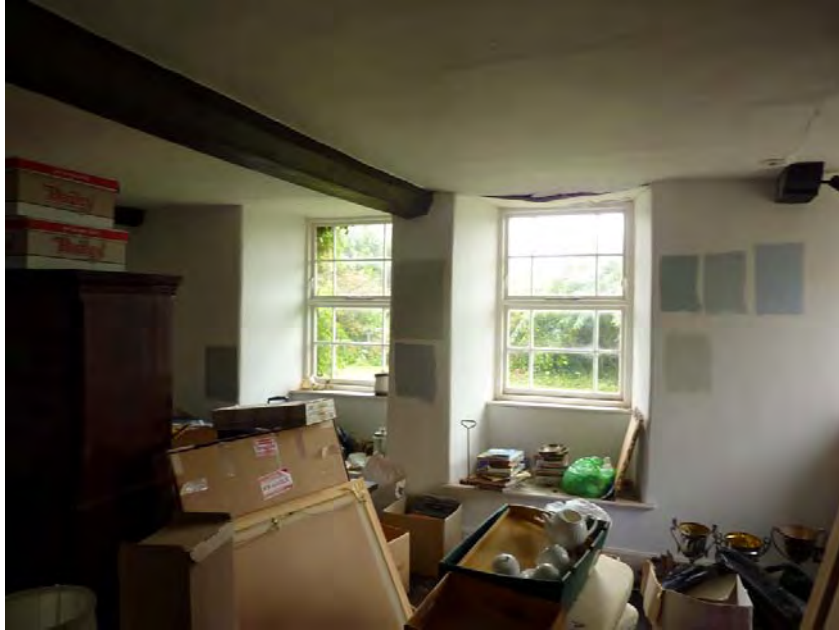
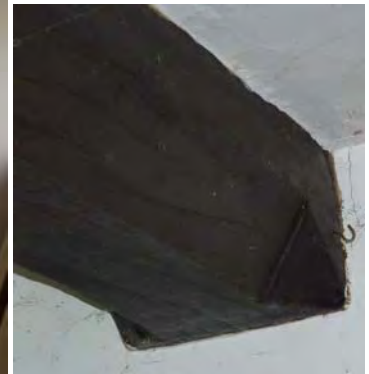
Looking south; detail of wide chamfered beam and rolled stop

This room may have been the hall of the 16<sup>th</sup> or early 17<sup>th</sup> century house. Its exposed beams have similar stops to those in the cellar below, with wide chamfering comparable to that period. The windows are all modern replacements, and the one to the left of the fireplace replaced a blocked stone cross window some time prior to 1989. The other alcove, retaining an 18<sup>th</sup> century open cupboard (with modern copies of shaped shelves), retains the cross window on the rendered exterior. The current owners restored the floorboards.

The southern stops of the beams are embedded in the walls when the front wall was rebuilt in the mid 18<sup>th</sup> century. The curved fireplace has had similar treatment to that in the Hall, possibly also c1900-1930s. The stonework above the fireplace has certainly been rebuilt between the lintel and the ceiling, as diagonal lines either side show.

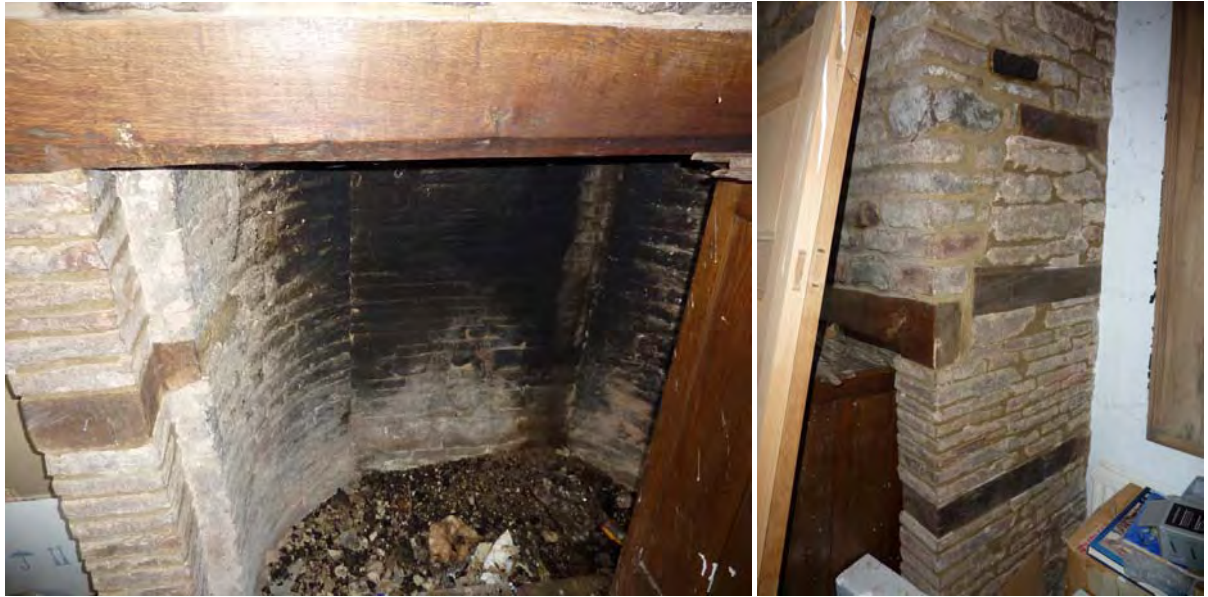
Rebuilt fireplace; 18<sup>th</sup> century cupboard with modern shelves; doorcase with modern copied door, timber and sloping wall infill

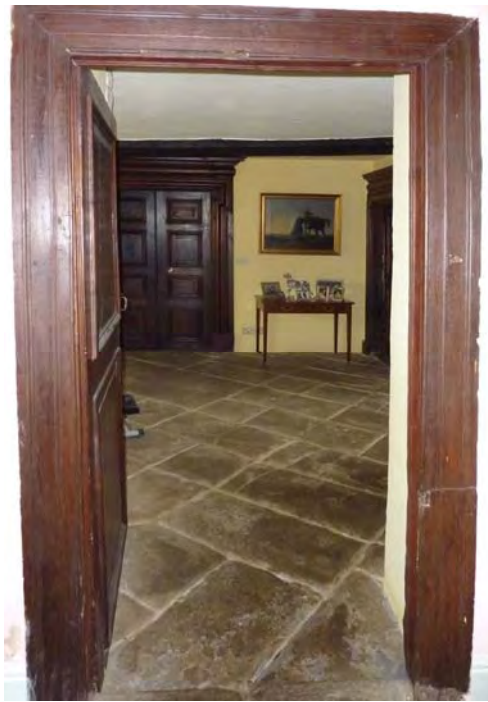
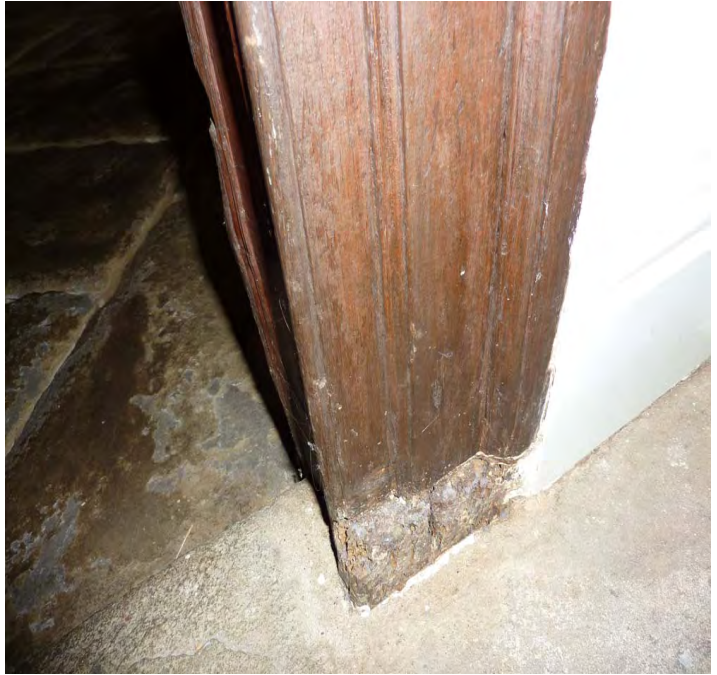
Doorcase and detail of base of jamb; Curve of front wall

This room was being used as the kitchen in 1975 (L Hall:1983) and the current owners have returned the fireplace to its original proportions. There is an 18<sup>th</sup> century cupboard to either side, one possibly a gun cupboard. The windows are modern sashes, and the south wall, like that in the parlour, appears to have been deepened, the stops on the south side of the ceiling timbers enclosed within it, and supported by a new timber corbel bolted into the underside of the beam. The beam in the bedroom above is similar. It is probable that the original beams continued across the kitchen passage below the lowered ceiling, and the room was once the same depth as the Parlour.

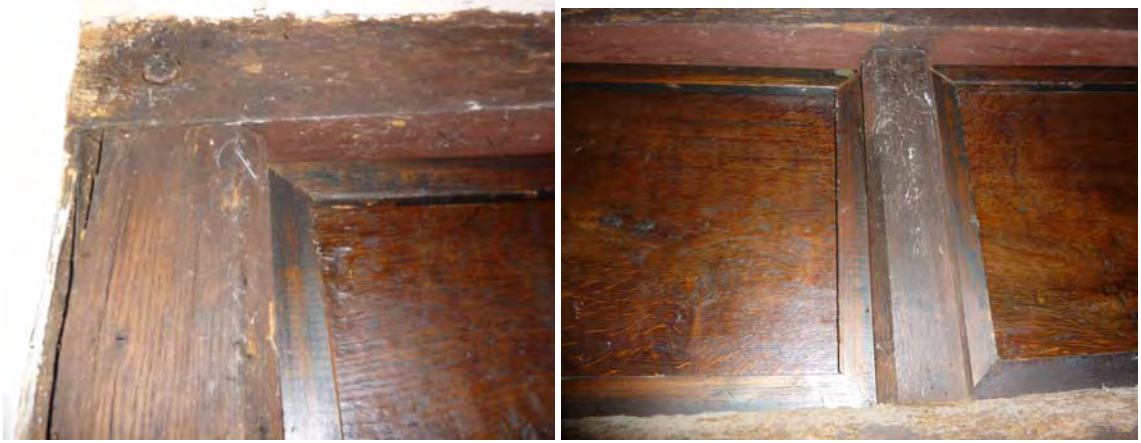
Detail of panelling above eastern doorway; weathered jamb; Hall door (modern copy) and door jamb

The wide kitchen passage has a flagstone floor, restored by the current owners who removed layers of bitumen covering. At either end is a square headed timber doorway, the western end retaining the moulded chamfering and stops which are circa mid 17<sup>th</sup> century. The eastern end which was originally the back door, has lost its details due to weathering. The eastern front shows signs of heavy weathering consistent with it being originally on the exterior and the bottom of the jambs have been cut away, suggesting the presence of an earlier threshold. Above this end is a two panelled section, much of it covered on the eastern front. This may have been glazed once, to provide some light into the passage. The wall runs back from the doorway for a short distance before returning to either side. In the centre of the passage are two opposing doorways; the one into the Sitting Room [00-04] now blocked, the other into what is now the Kitchen [00-06]. The lowered ceiling is modern.

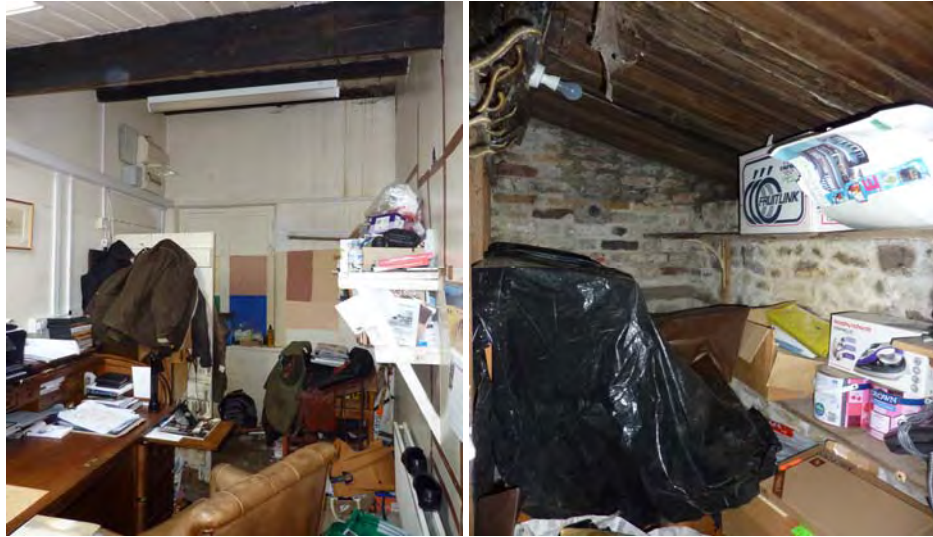
Office looking west; adjacent Store

The two sections of lean-to against the eastern end of the house are late 19<sup>TH</sup> - 20<sup>th</sup> century. The northern end, comprising the Utility Room, Office and store rooms [00-07 a-b] was built between the 1920s and 1960s, whilst the southern end, comprising a lobby and cloakroom, dating to c1880s, has been rebuilt in the 20<sup>th</sup> century. The former retains a blocked window to the south of the kitchen chimney breast. The stores are stone built, the office walls clad with plaster board. The roof is off timber cladding.

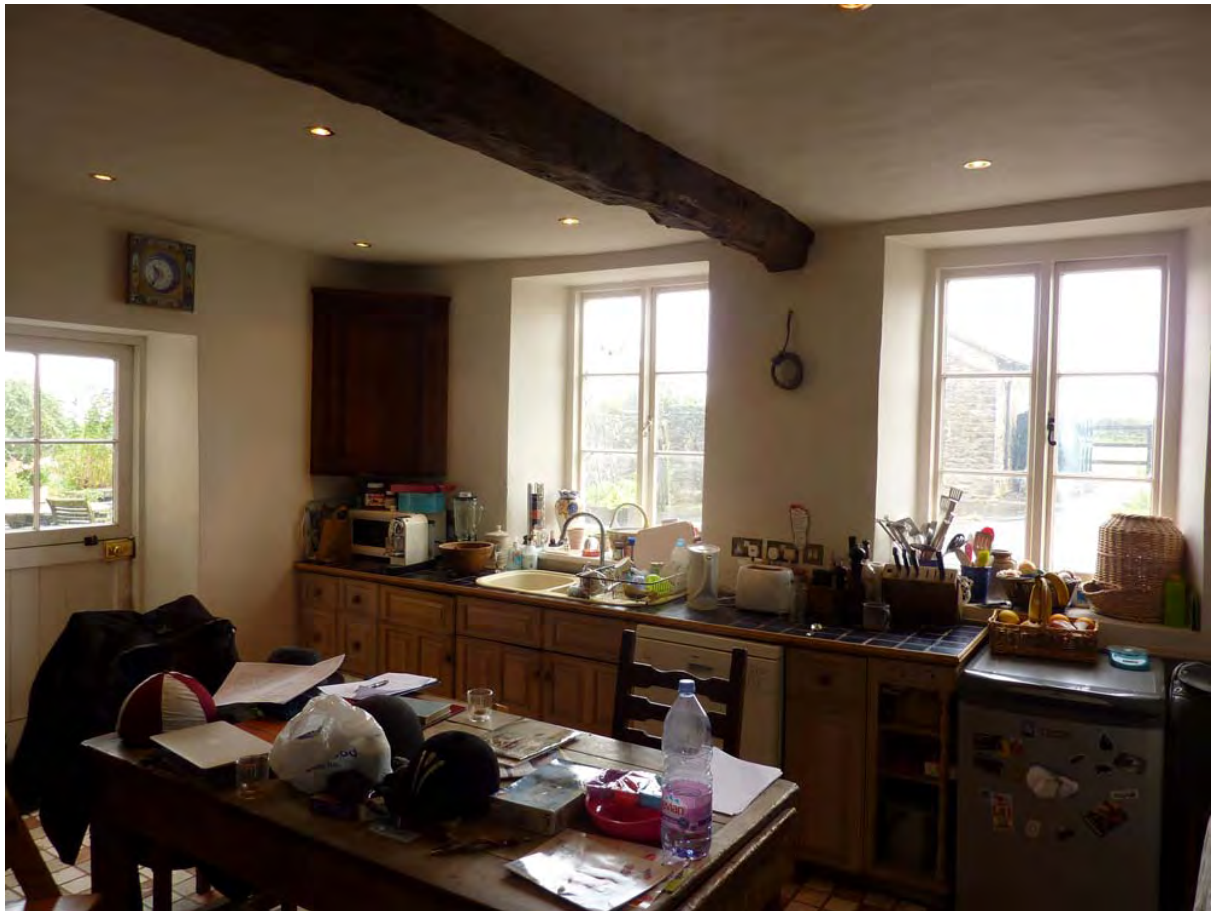
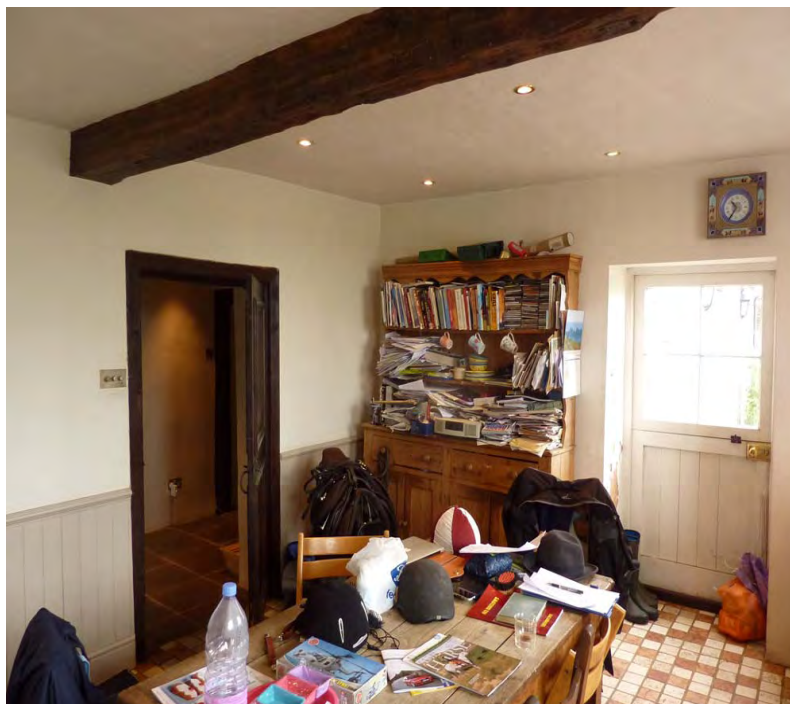
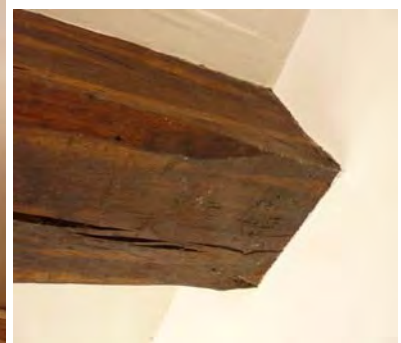
Kitchen looking onto passage; chamfered stop 18<sup>th</sup> century

The doorway into the kitchen suggests there may have been an earlier single storey building before the present kitchen was added in the 18<sup>th</sup> century, probably built as a dairy and certainly being used as such in 1975 (L Hall). The stone voussoirs over the Aga range fit the space exactly suggesting they may have been inserted more recently. The roughly hewn ceiling timber also suggests this was a dairy/kitchen rather than a family room, the narrow chamfer and stop 18<sup>th</sup> century. There was a window to the south side of the fireplace in what is now an airing cupboard. The external kitchen door is modern and replaces modern French windows. The door onto the passage is a modern copy.

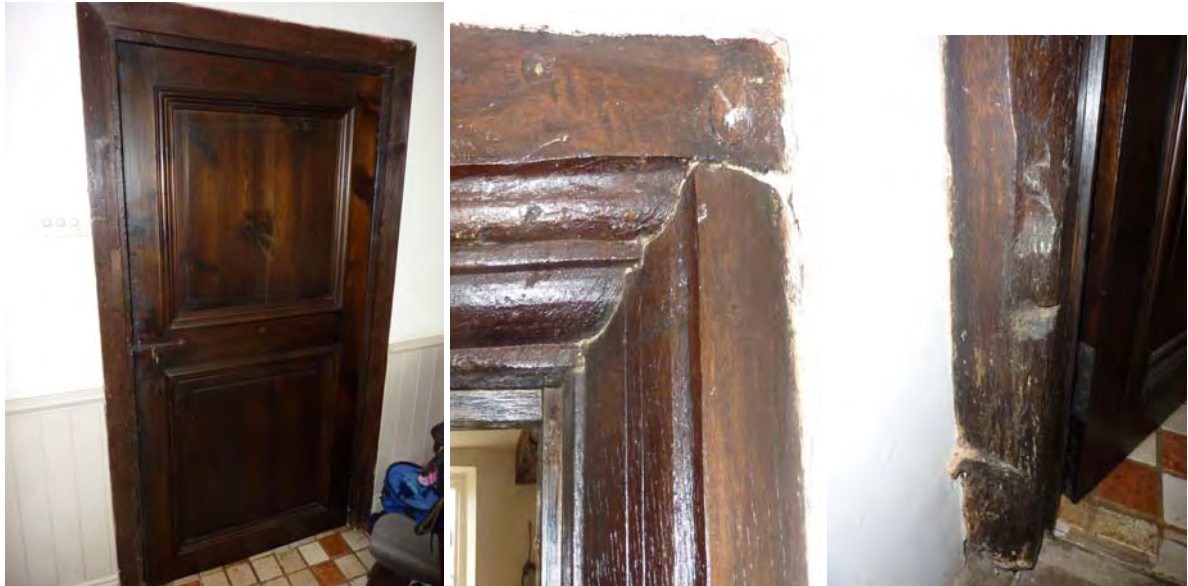
Kitchen door (modern copy) and detail of doorcase; carved stop on door jamb

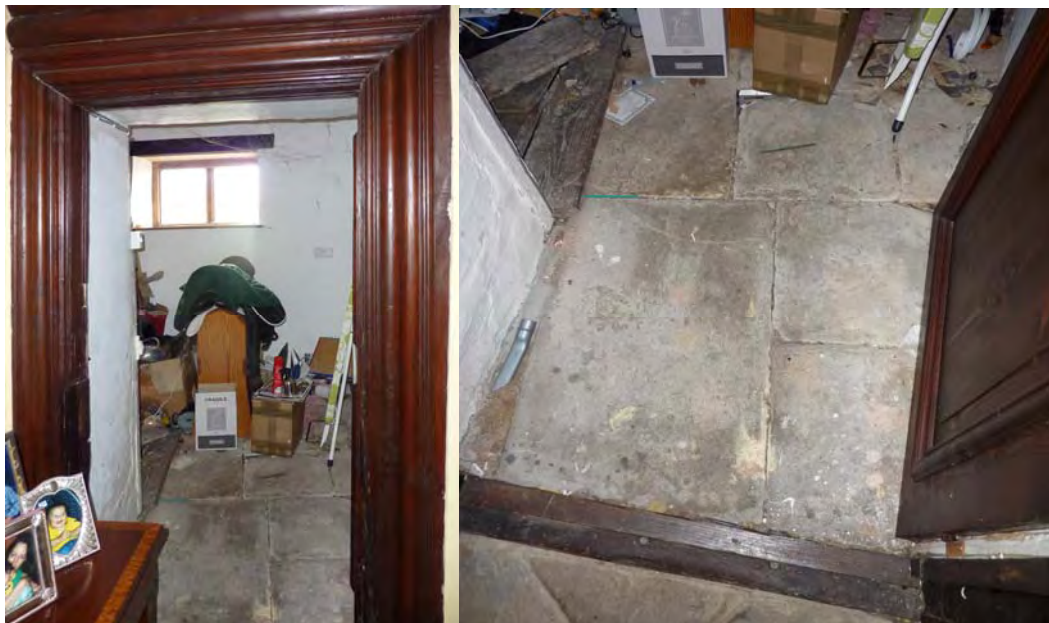
Lean-to looking north through bolection moulded doorway; flagged floor at an angle

The lean-to retains some intriguing features, and appears to have been built before the addition of the square stair tower, confirmed by the large blocked window on the east wall, which forms the west wall of the tower. Now a store room and adjoining log store with exterior doorway, it had another doorway where the c1900 timber leaded casement has been relocated. There is an adjoining door between the two, with further blocked windows and a doorway in the west wall. High above on the north wall of Bedroom [01-01] is a blocked timber ovolo mullion. In the eastern store is a blocked doorway plastered over which appears to have a blocked archway above it, in the north wall of the Parlour [00-01].

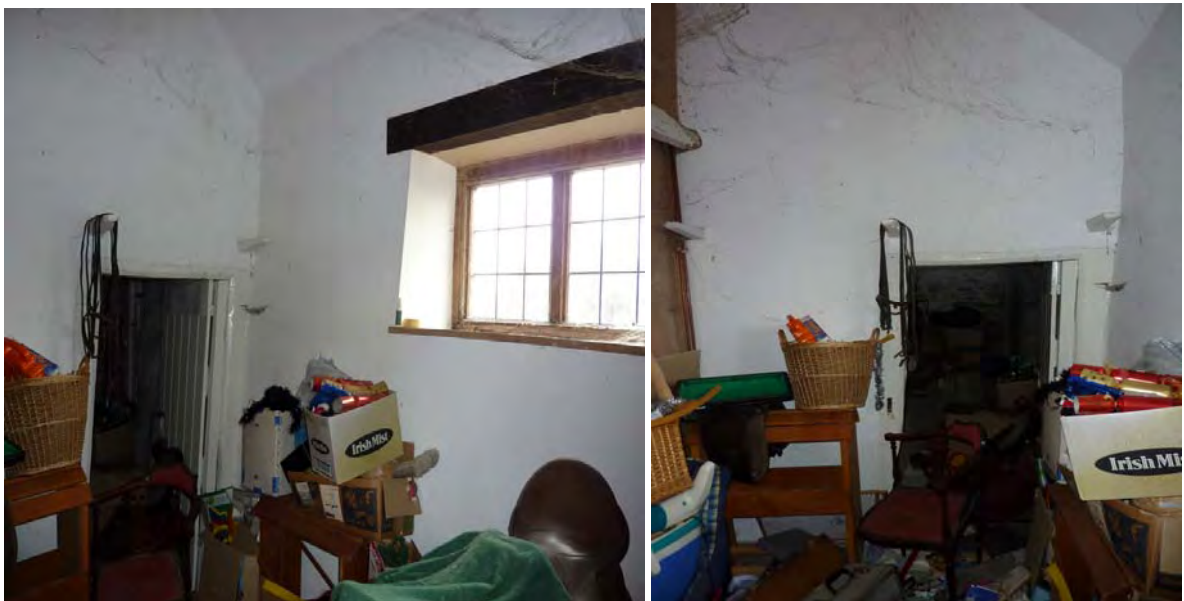
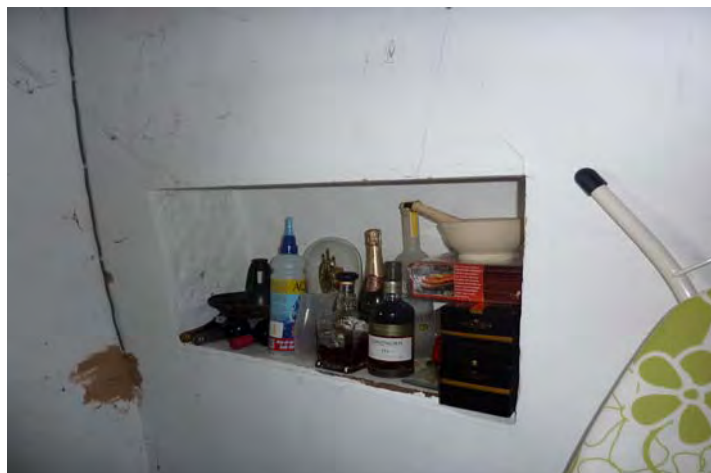
Blocked east window in stair tower wall

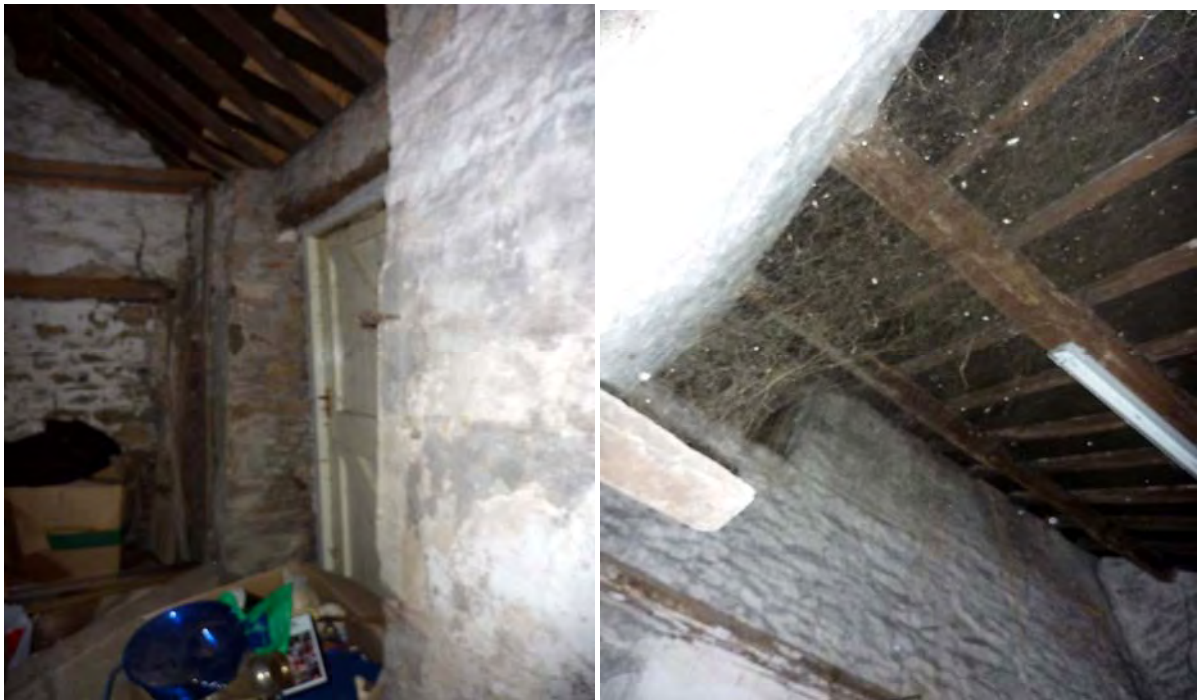
Roof above log store; blocked doorway on south wall with shelving

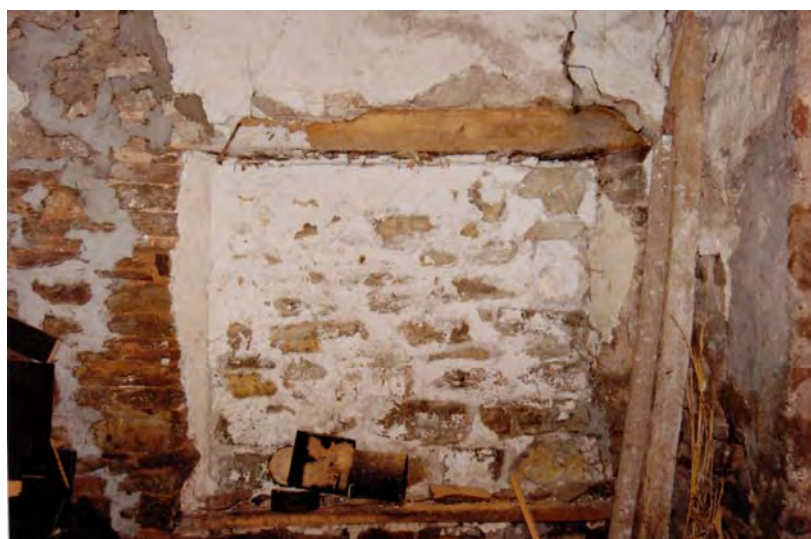
Blocked window in west wall

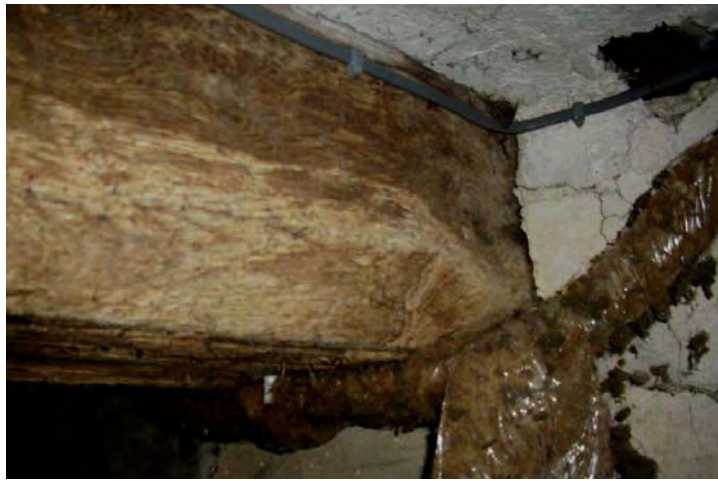
Chamfered beam and stop, similar to that in parlour above; cellar stairs (B Jones)

The cellar has a flight of steps, made from rubblestone and capped with concrete, which runs down from the lean-to floor. It is probable that the cellar was once accessed from what is now the cupboard underneath the staircase, which is 2 steps lower than the Hall floor. The cellar is below the Parlour, with a wide chamfered late 16<sup>th</sup> or early 17<sup>th</sup> century stopped central beam. It has been cut away to heighten the cellar doorway, another indication that the doorway and steps are later. There are two windows in the south wall, raised above the ceiling level and shown blocked on the exterior wall.

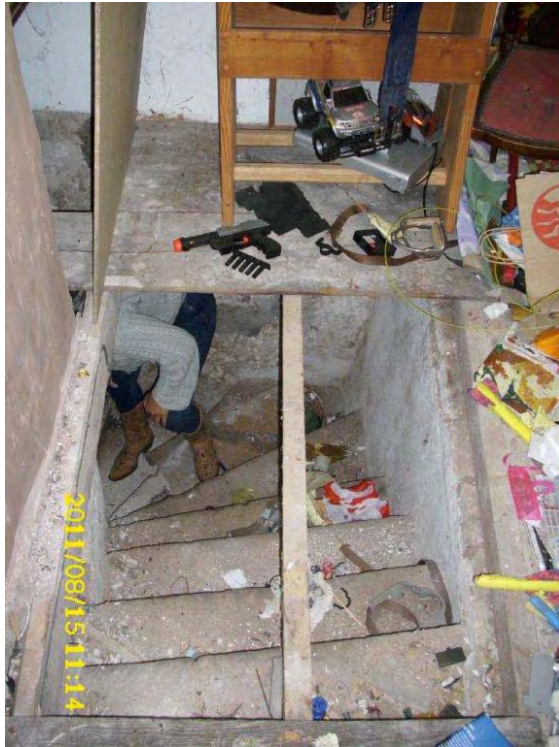
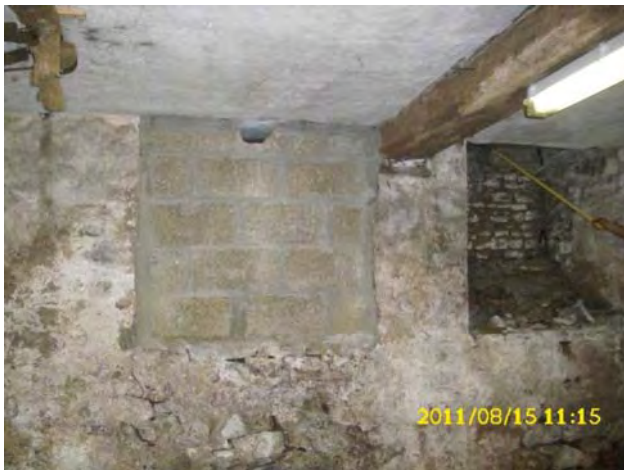
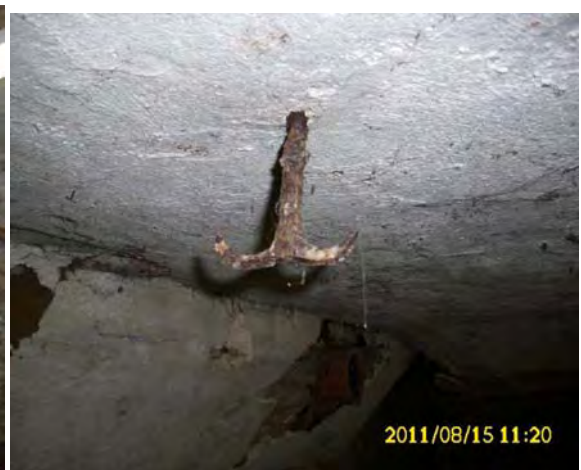
Blocked windows in south wall; meat hook (B Jones)

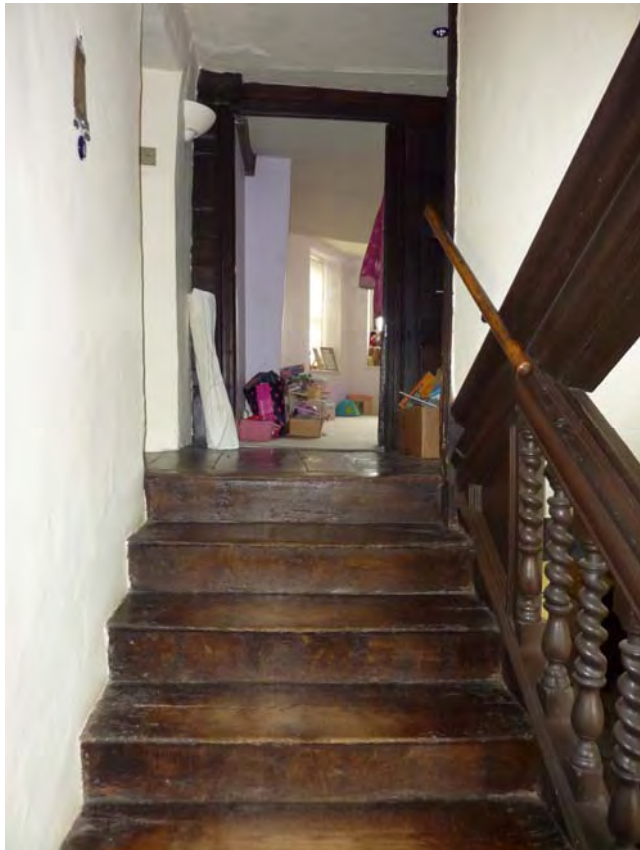
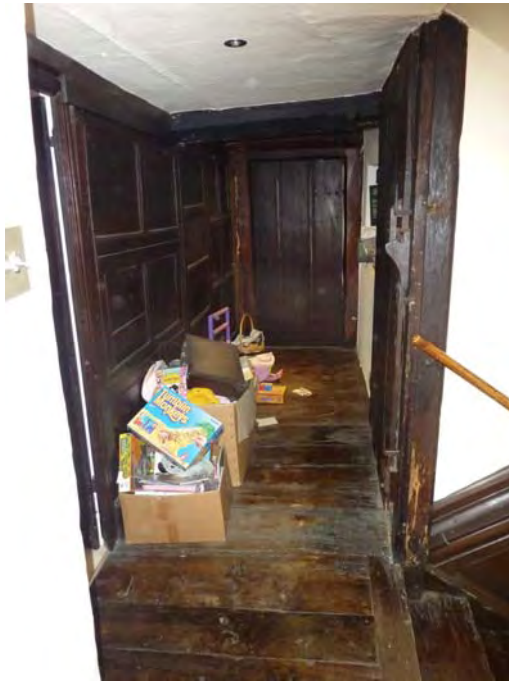
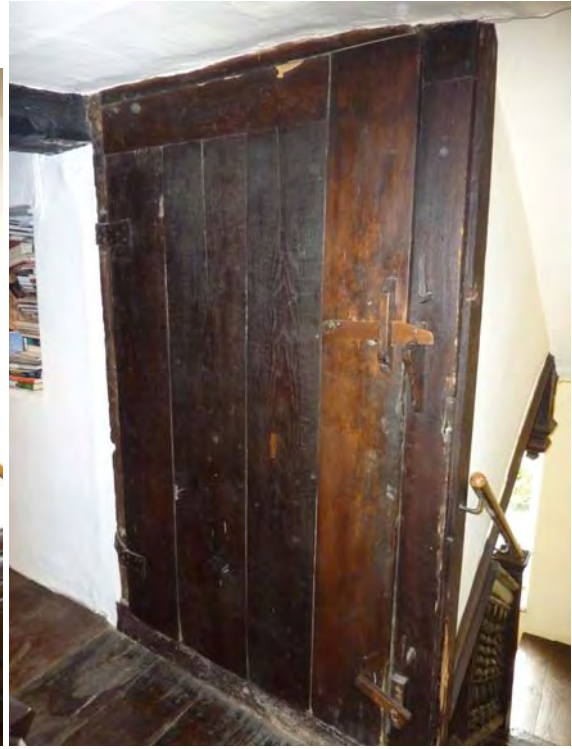
Landing looking west; widened attic stairs door

The staircase landing originally only accessed the western half of the first floor; the eastern passage was made much later. The floorboards are wide and the landing panelled with panels rescued from the fire damaged hall (L Hall). The two oldest bedrooms [01-01 & 01-02] lead off it as well as the doorway up to the attic staircase (also in the stair tower). Here the carved chamfers and stops on the beams and door jambs remain, the ceiling lowered more recently. The continuous beams with distinctively carved stops show the passage was created later, and the doorway into room [01-02] was relocated from elsewhere, the joinery made to fit, although leaving gaps. This was possibly done in the 18<sup>th</sup> century when the eastern wall was breached.

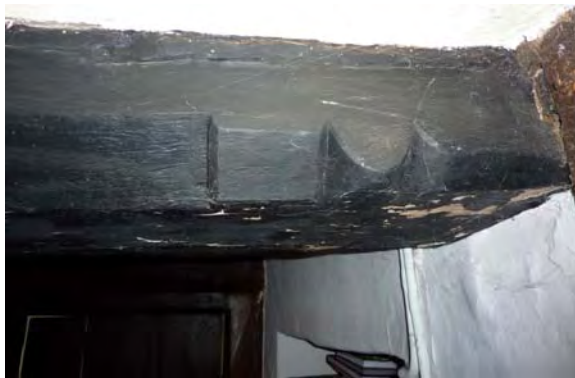
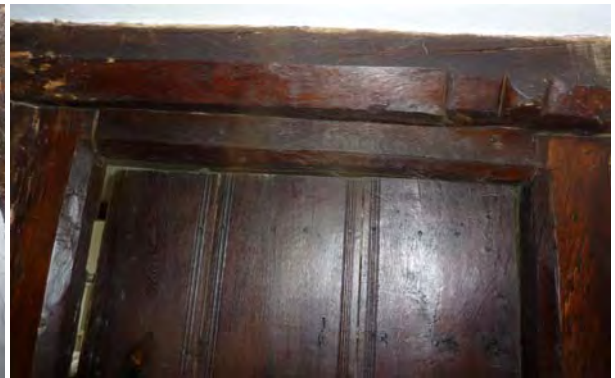
Detail of carved stops on beams; detail of bedroom door [01-01] and jamb

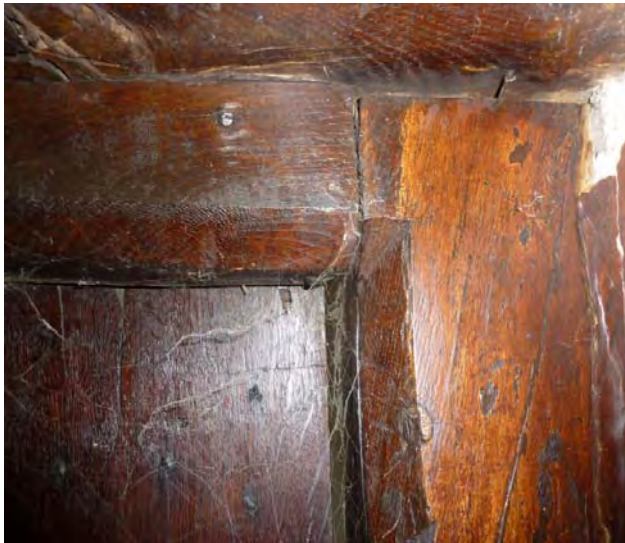
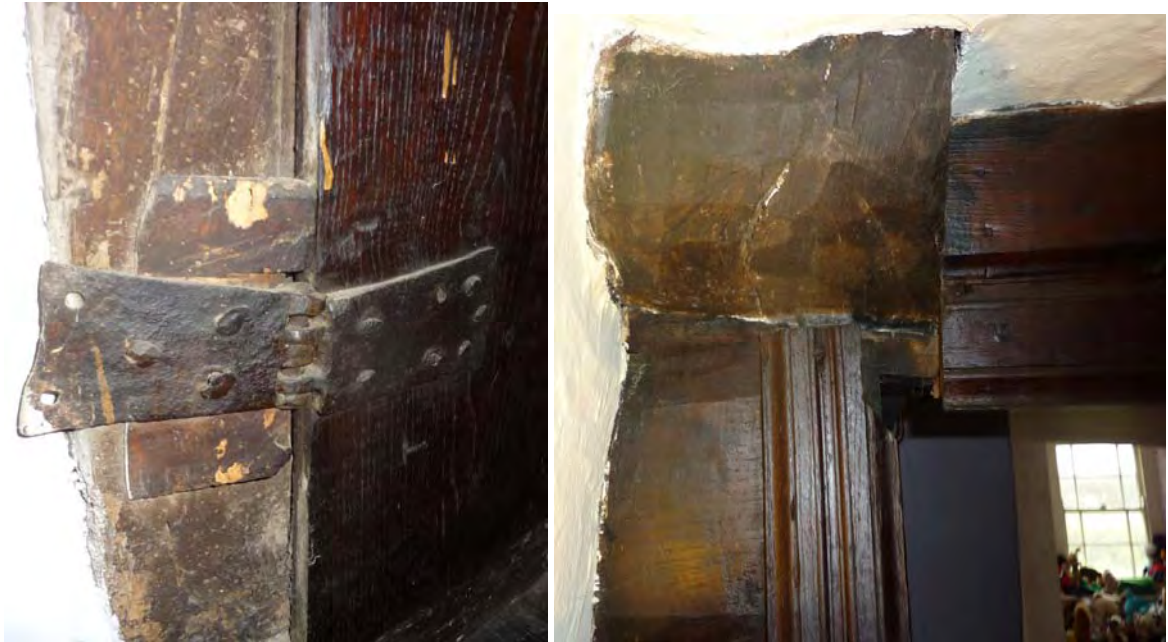
Detail of butterfly hinge on attic stairs door; cut off beam and later doorway made to fit

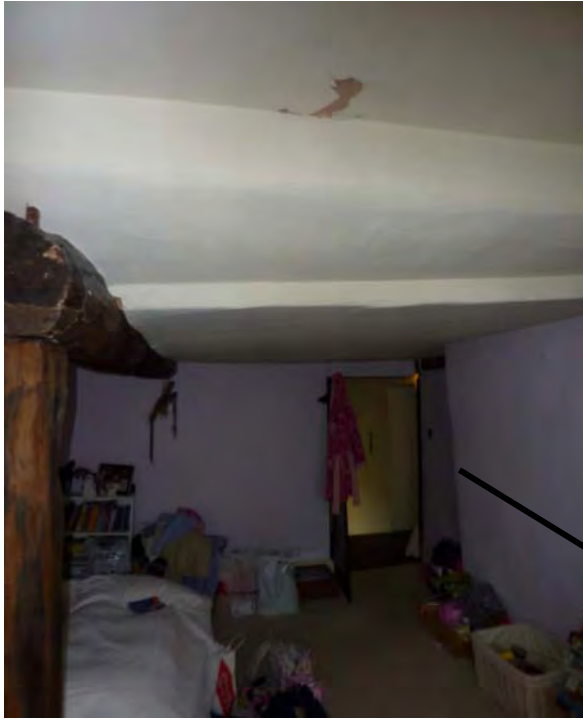
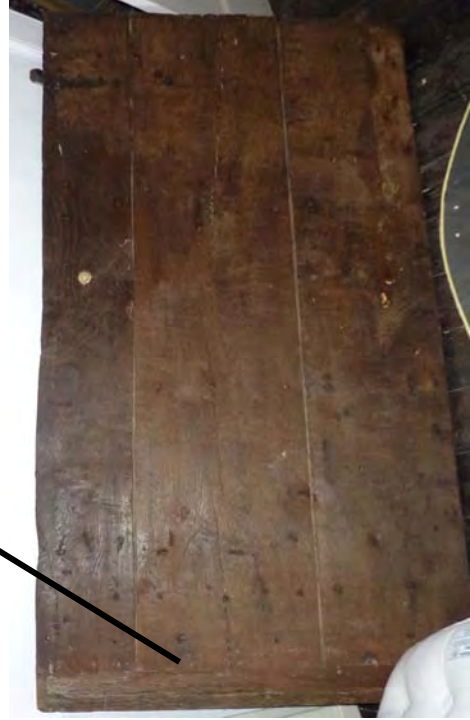
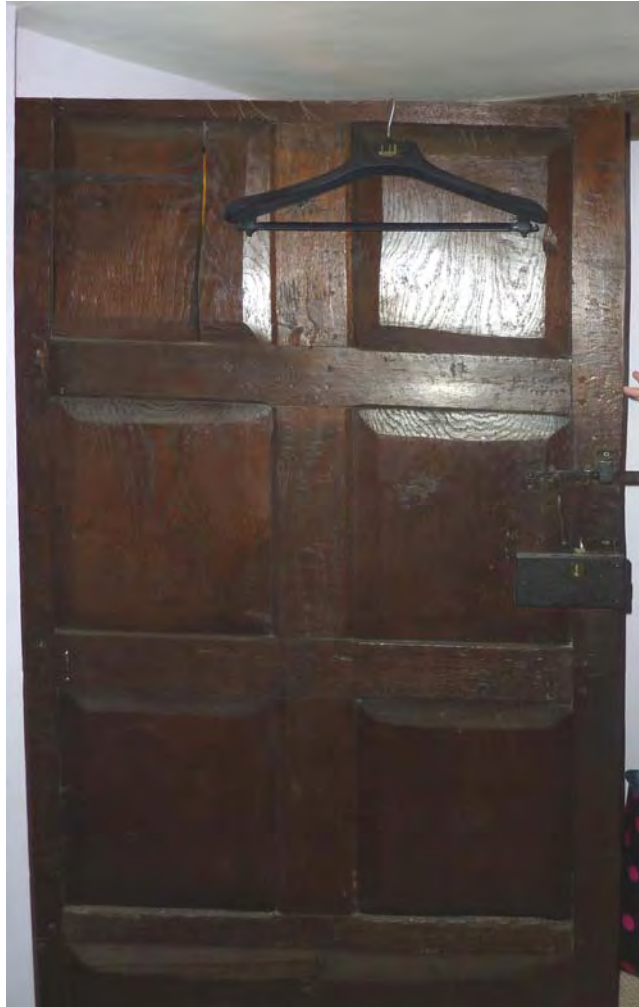
6 panelled 17<sup>th</sup> century door
